CALCIVIS Imaging System

Image Interpretation Guidelines

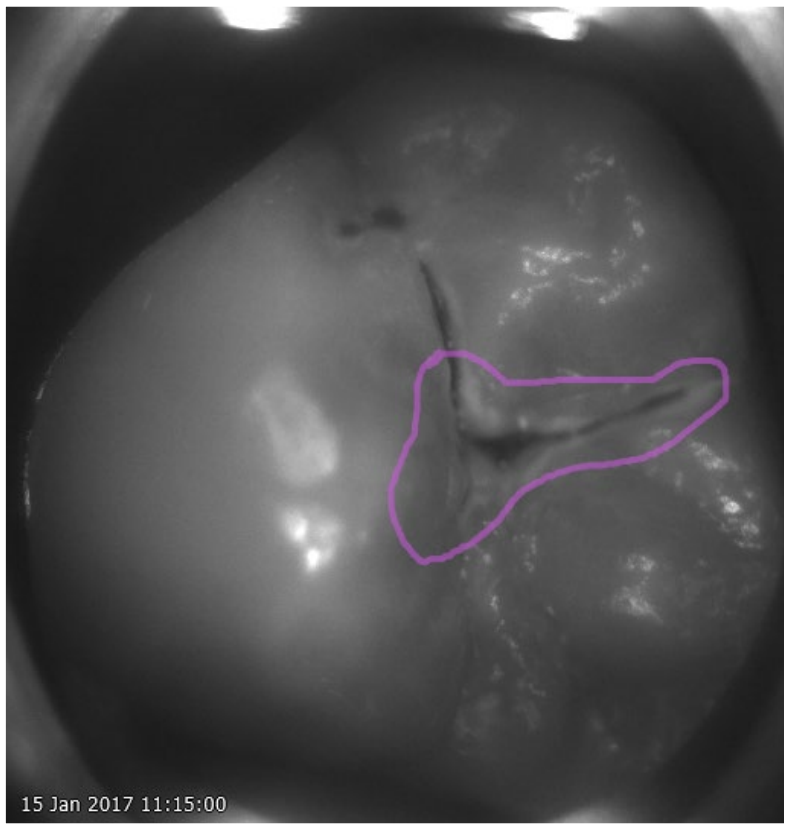
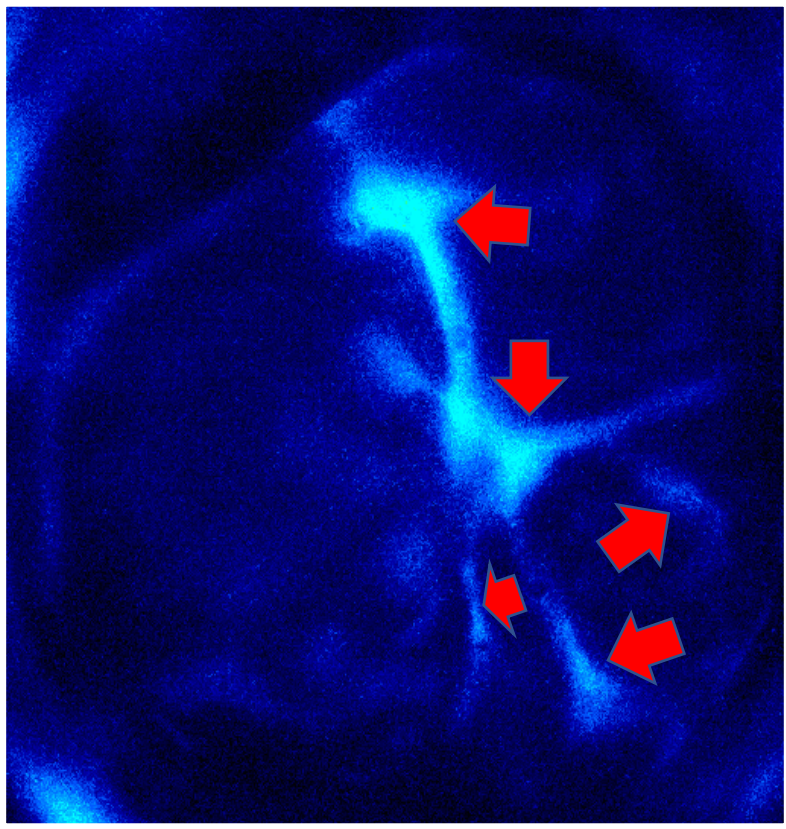
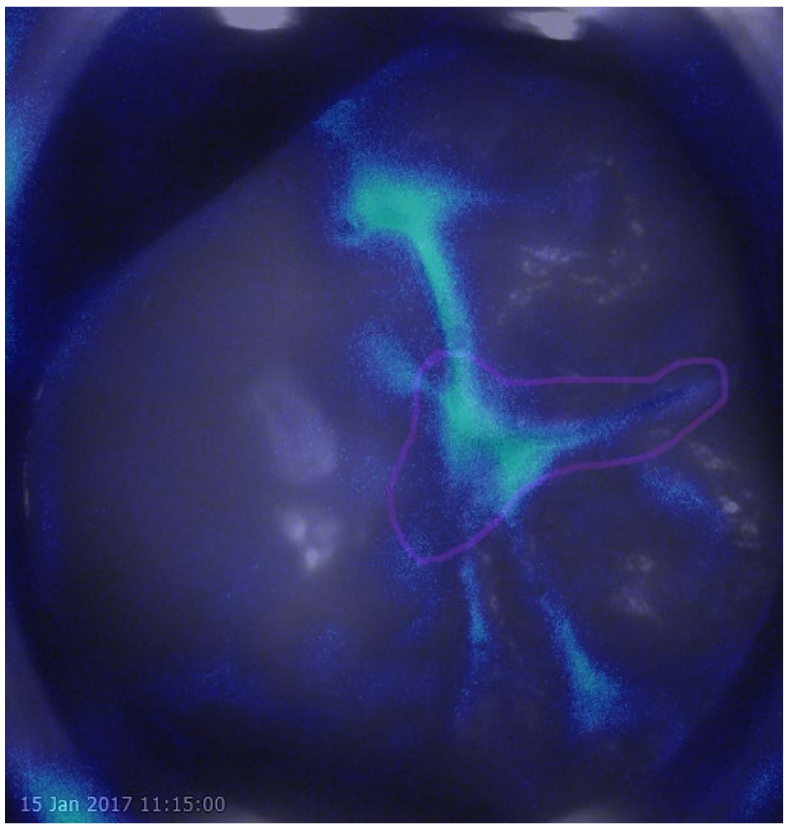
Fig. 1 – moderate active demineralization, associated with caries

Tooth 31 (LR7) Occ - moderate level of active demineralization (red arrows) in area marked by clinician before imaging, and also outside the area marked, indicating demineralization more extensive than initially thought.

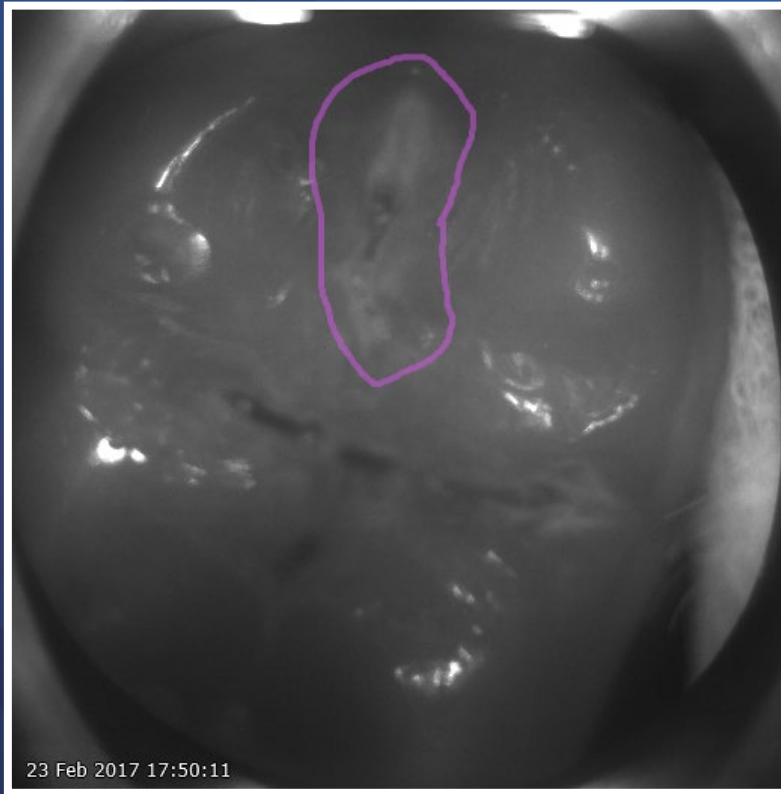
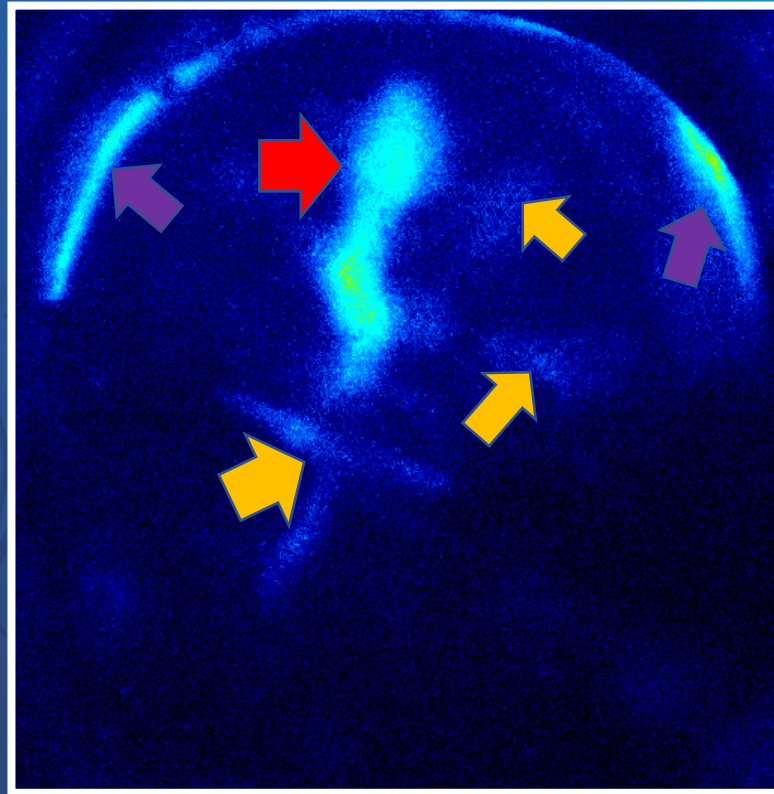
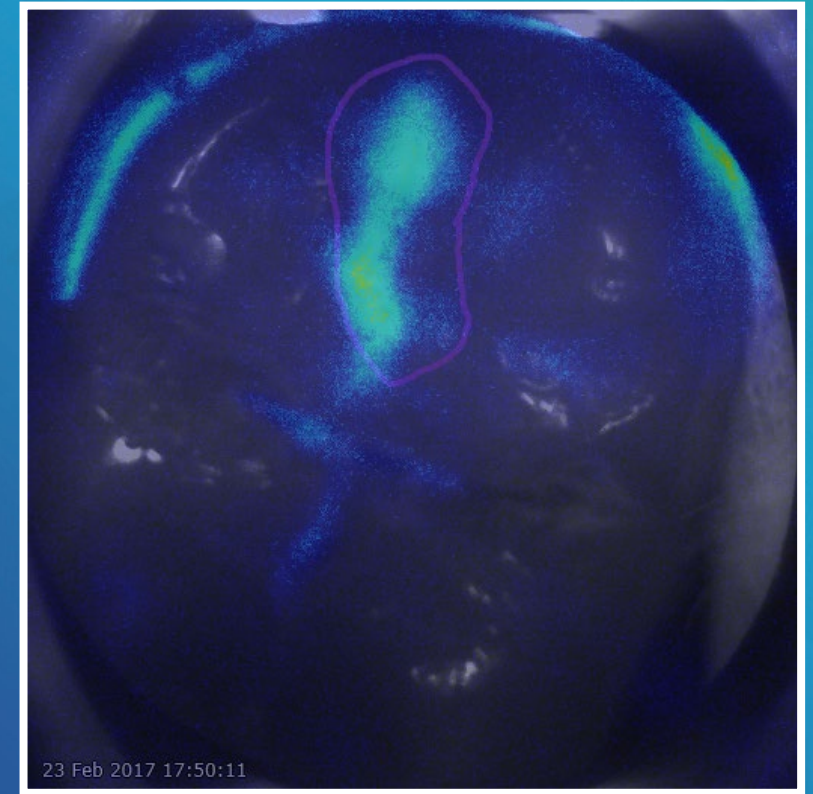
Fig. 2 – moderate and mild active demineralization, associated with caries

Tooth 31 (LR7) Occ - moderate level of active demineralization (red arrow) in area marked by clinician before imaging, and also mild levels (orange arrows) outside the area marked. Signal around edges of tooth caused by saliva (purple arrows).

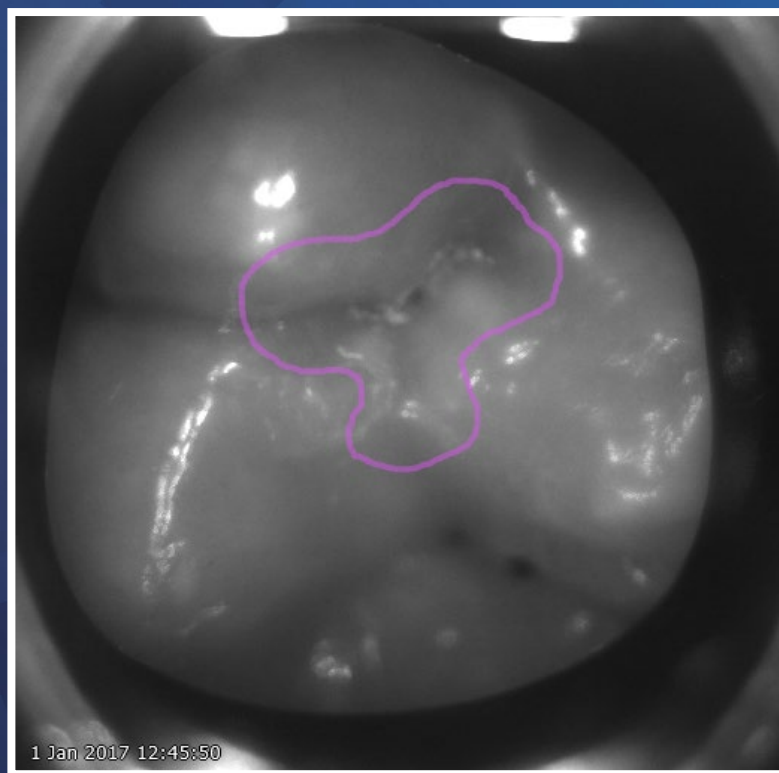
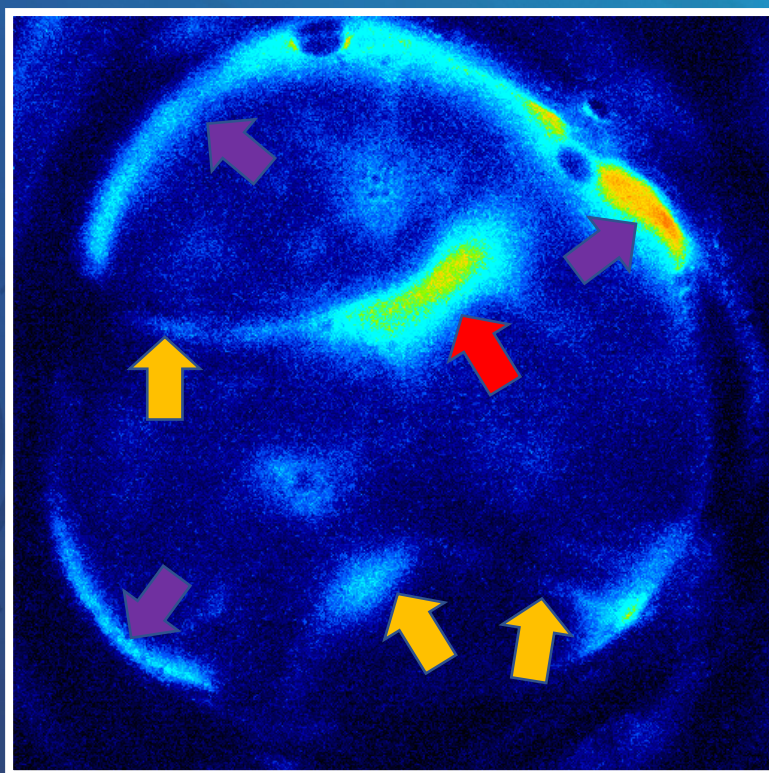
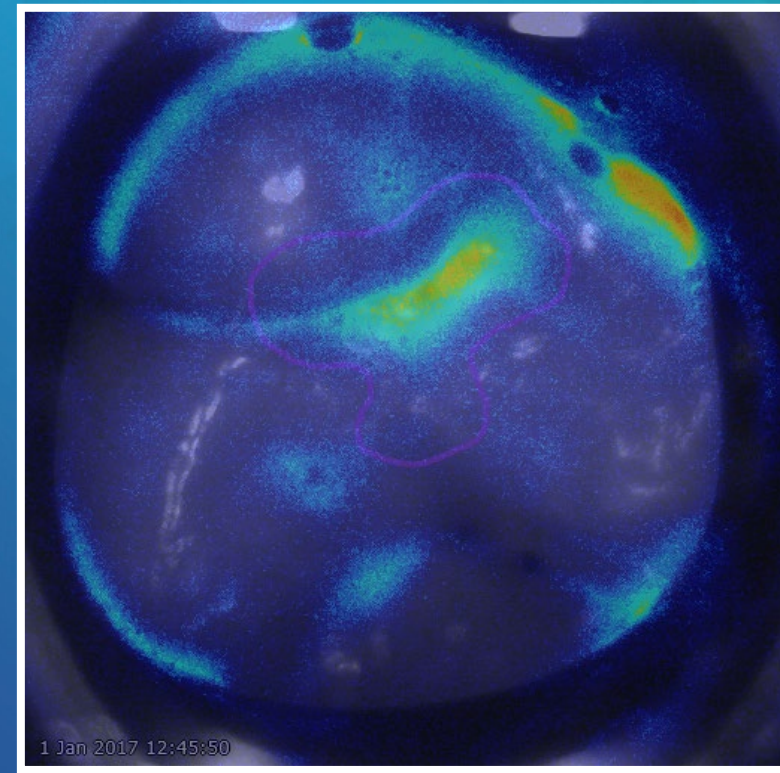
Fig. 3 – high, moderate and mild active demineralization, associated with caries

Tooth 3 (UR6) Occ - high level of active demineralization (red arrow) in area marked by clinician, and also mild and moderate activity (orange arrows) outside area marked, indicating demineralization more extensive than initially thought.

Signal around edge of tooth caused by saliva (purple arrows).

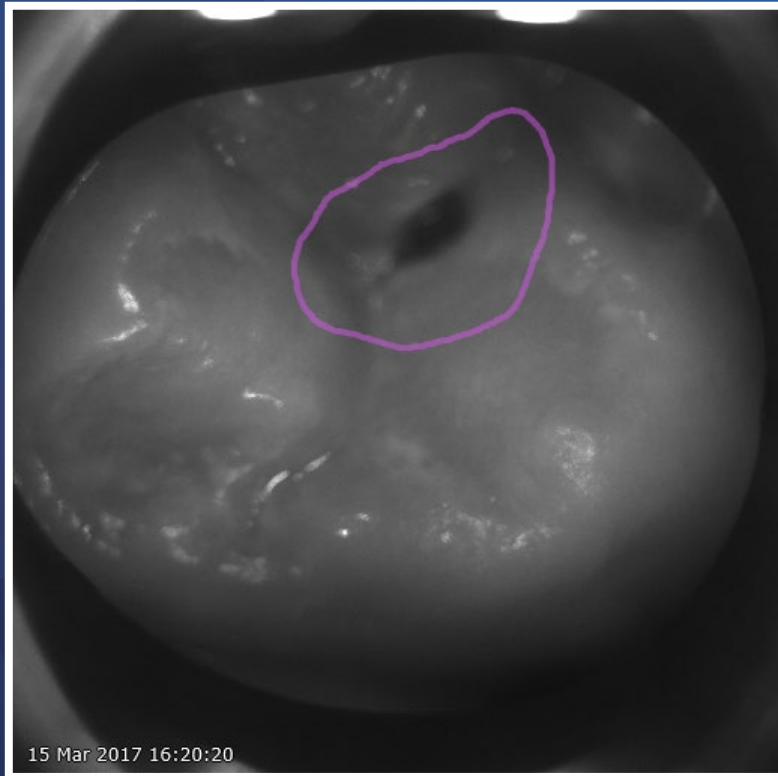
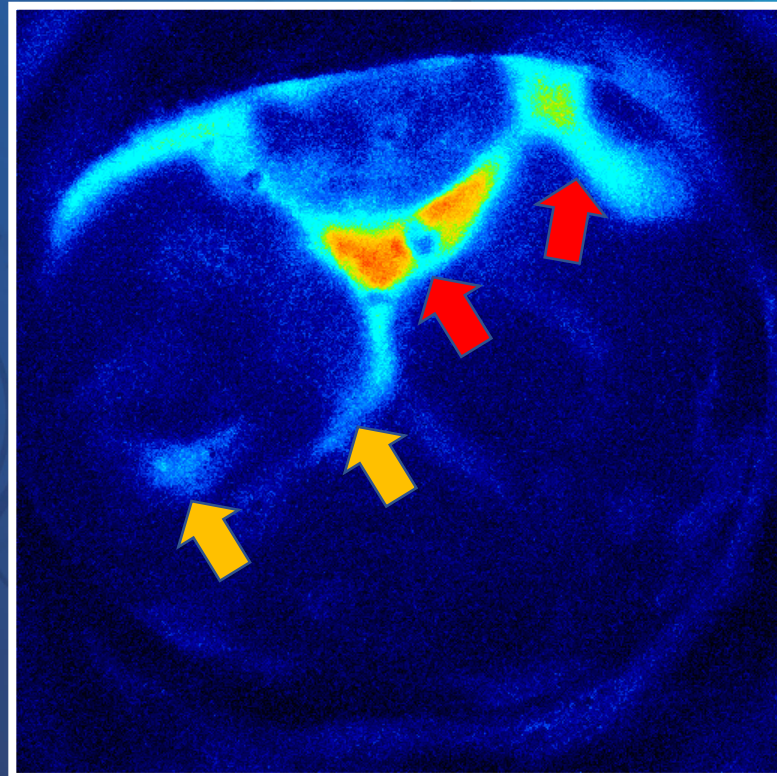
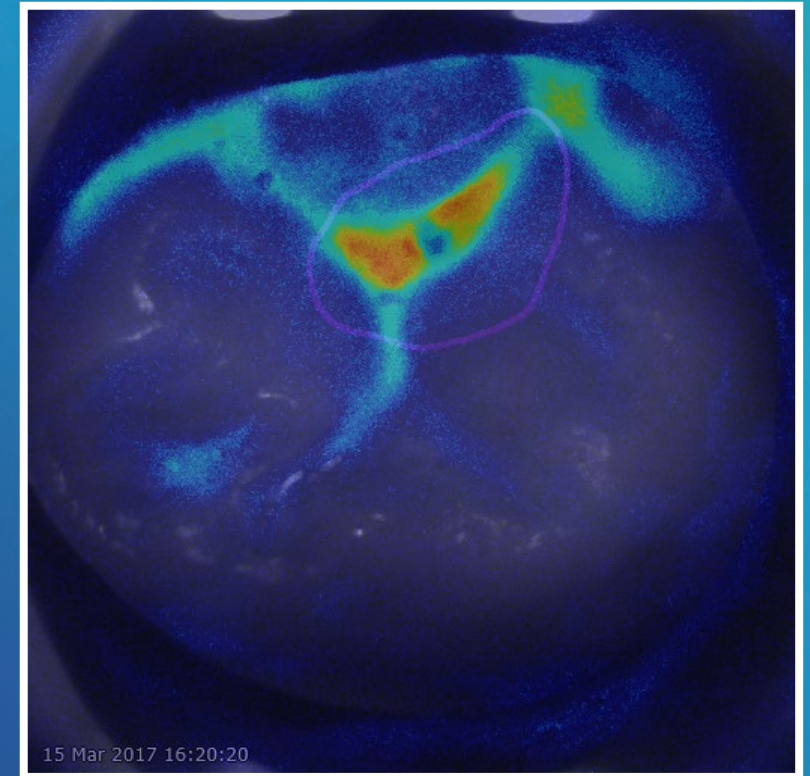
Fig. 4 – high, moderate and mild active demineralization, associated with caries

Tooth 15 (UL7) Occ - high level of active demineralization in area marked by clinician and also mild and moderate activity outside the area marked (orange arrows), indicating demineralization more extensive than initially thought.

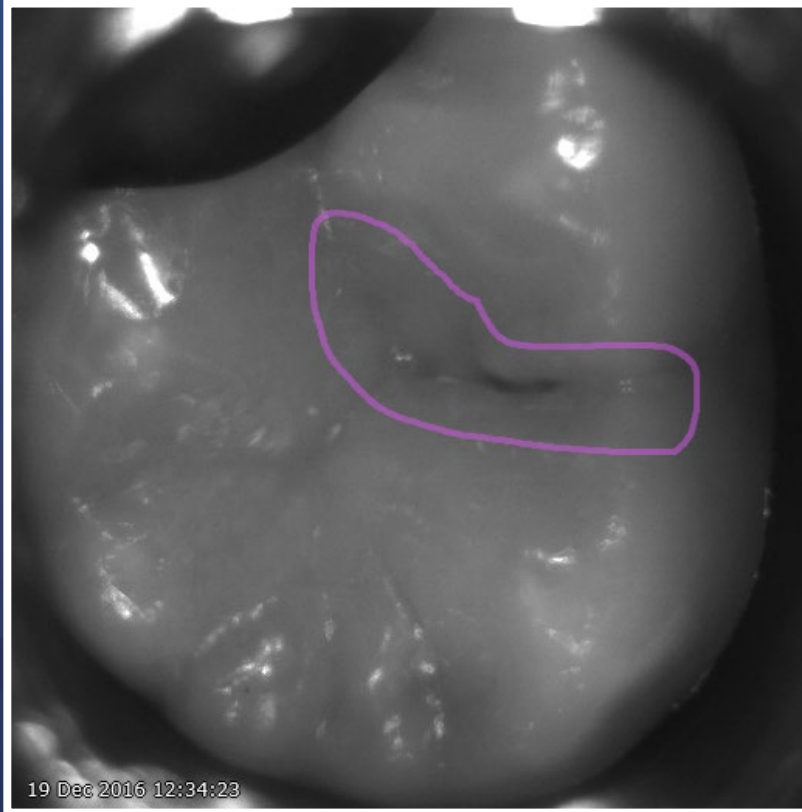
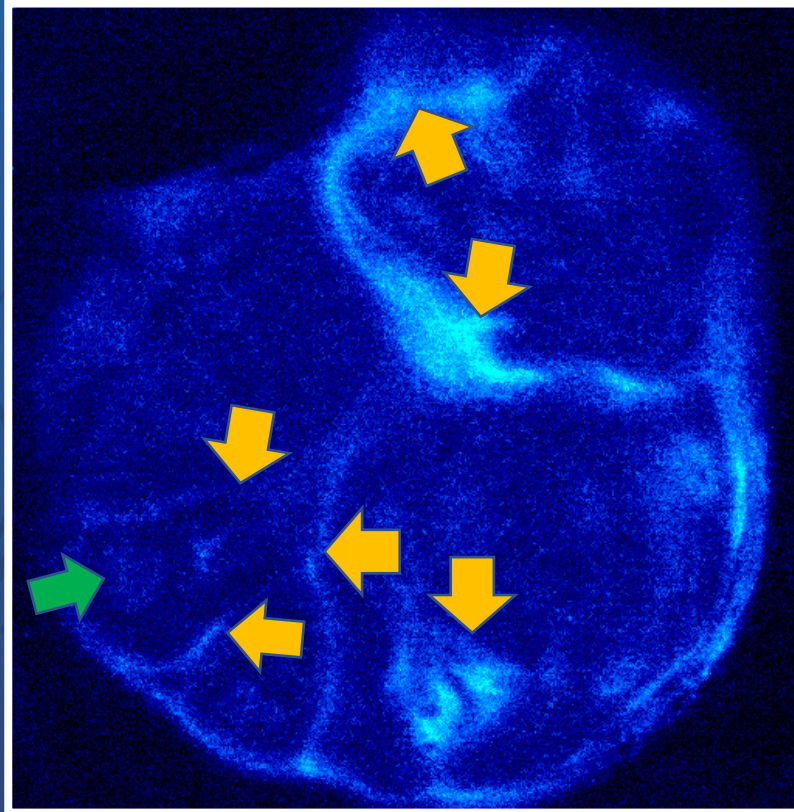
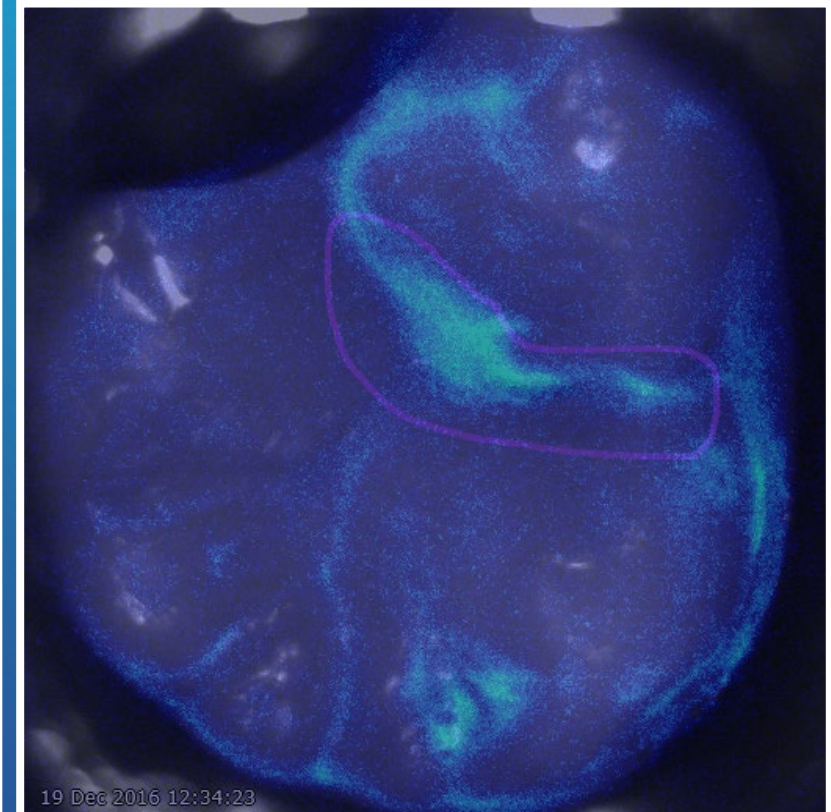
Fig. 5 – mild active demineralization, associated with caries

Tooth 3 (UR6) Occ - mild level of active demineralization (yellow arrows) in area marked by clinician and also outside area marked, indicating demineralization more extensive than initially thought. Area of non-caries related demineralization indicated by green arrow.

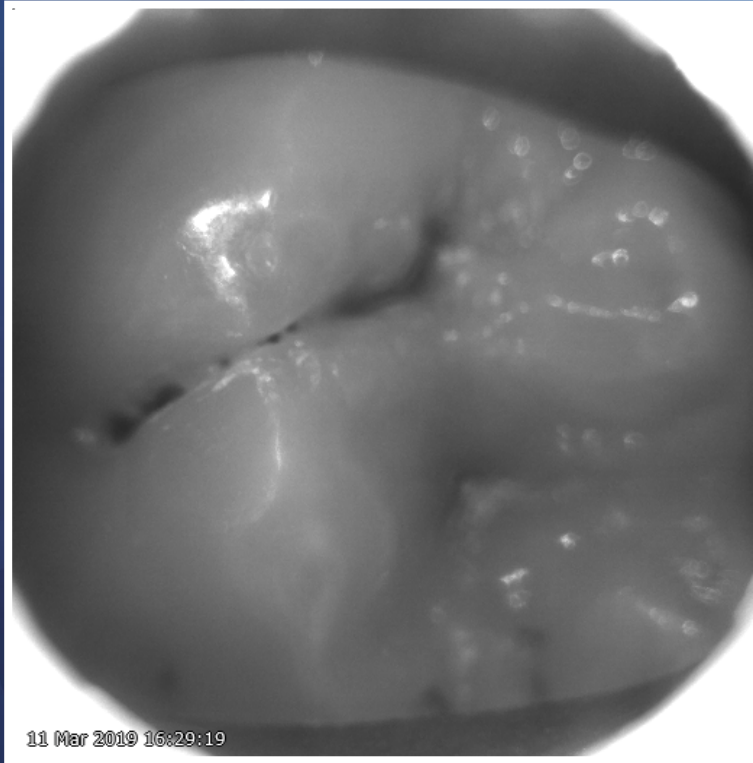
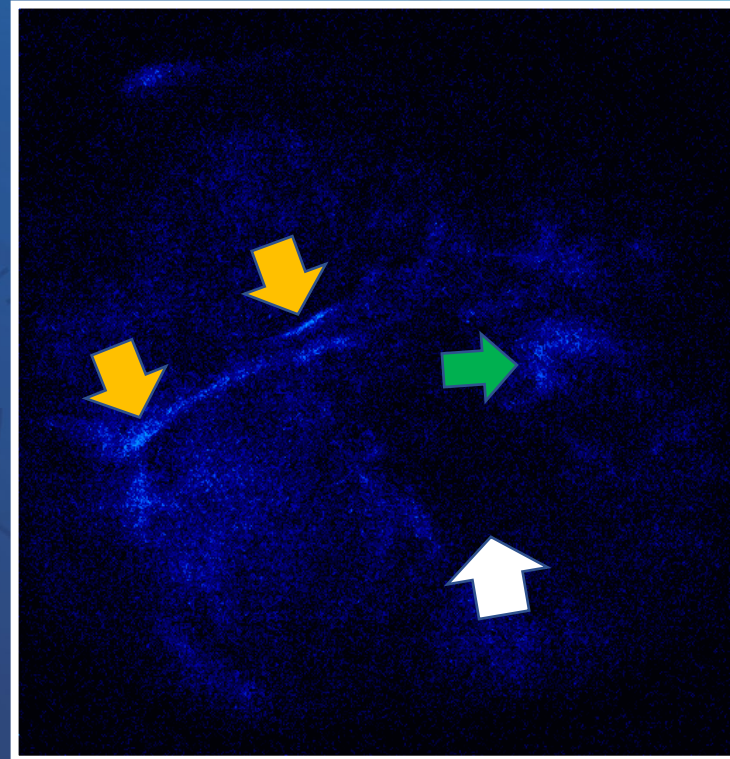
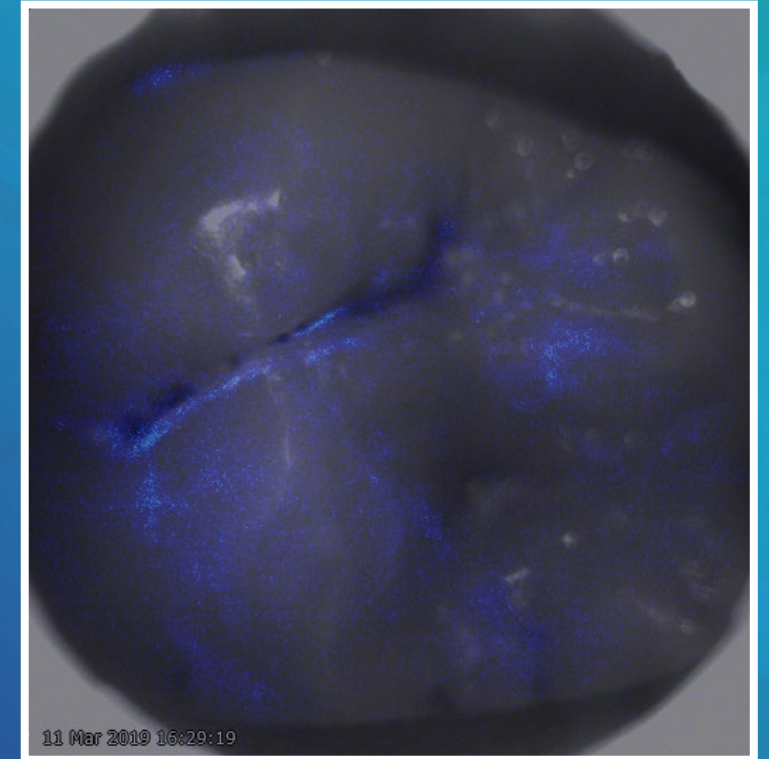
**Fig. 6 – mild active demineralization, associated with caries.
Arrested lesion with no activity.**

Tooth 3 (UR6) Occ - mild level of active demineralization (yellow arrows) associated with fissure. White arrow indicates arrested lesion with no activity.
Areas of non-carious related demineralization indicated by green arrow.

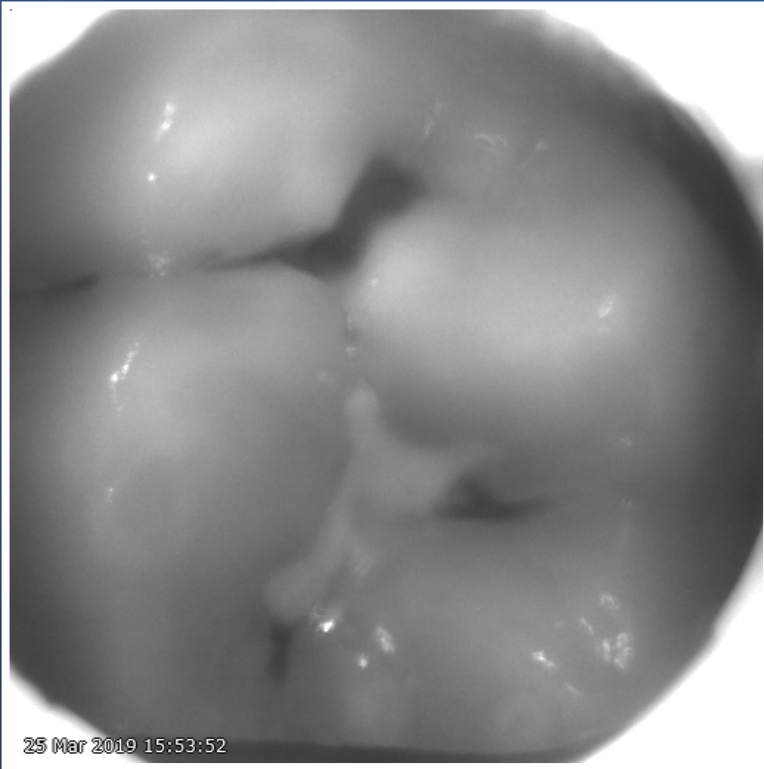
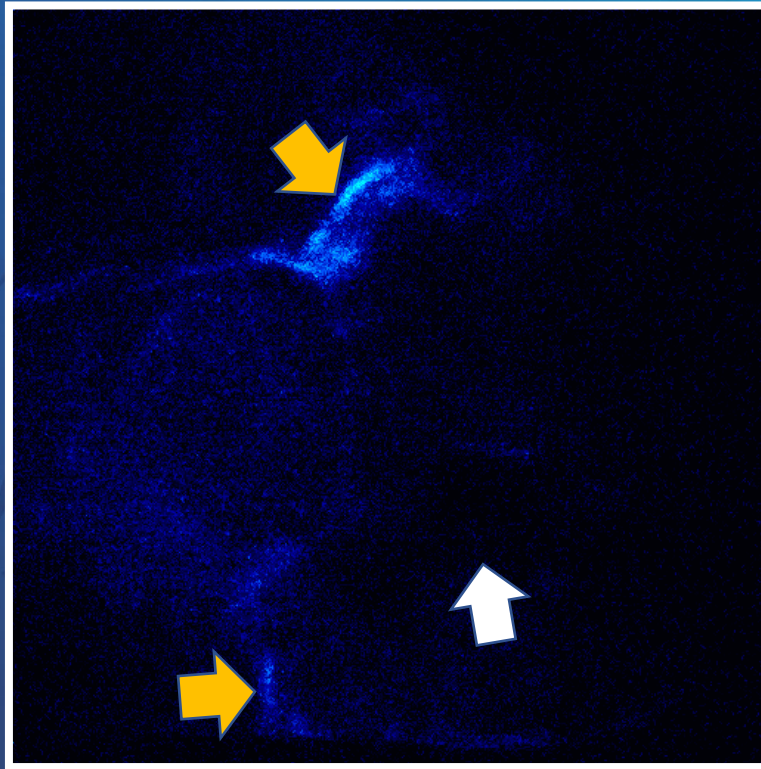
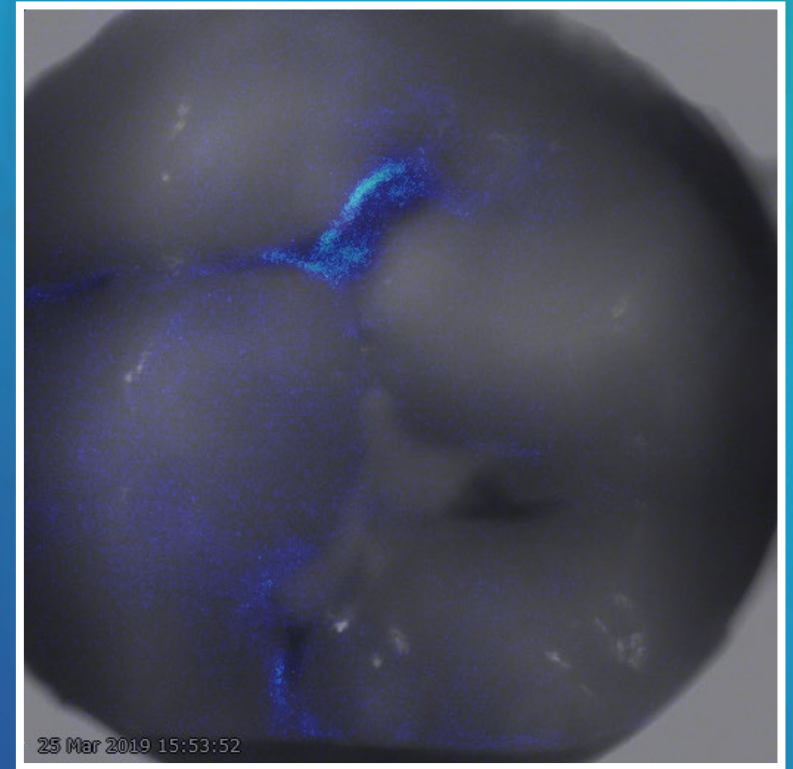
**Fig. 7 - mild active demineralization associated with caries.
Arrested lesion with no activity.**

Tooth 3 (UR6) Occ - mild level of active demineralization (yellow arrows) associated with deep fissure (distal) and fissure sealant (mesial).

White arrow indicates arrested lesion.

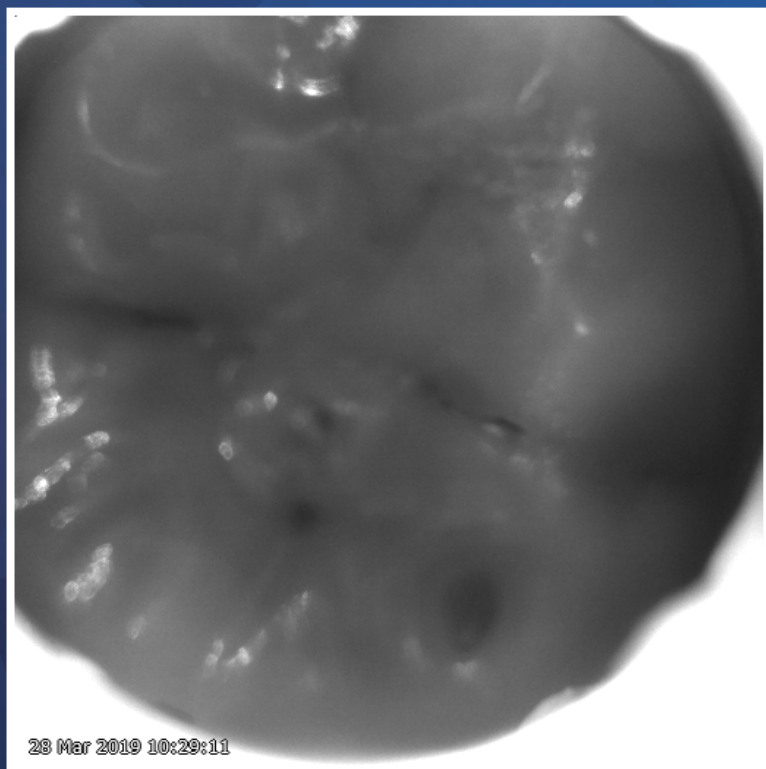
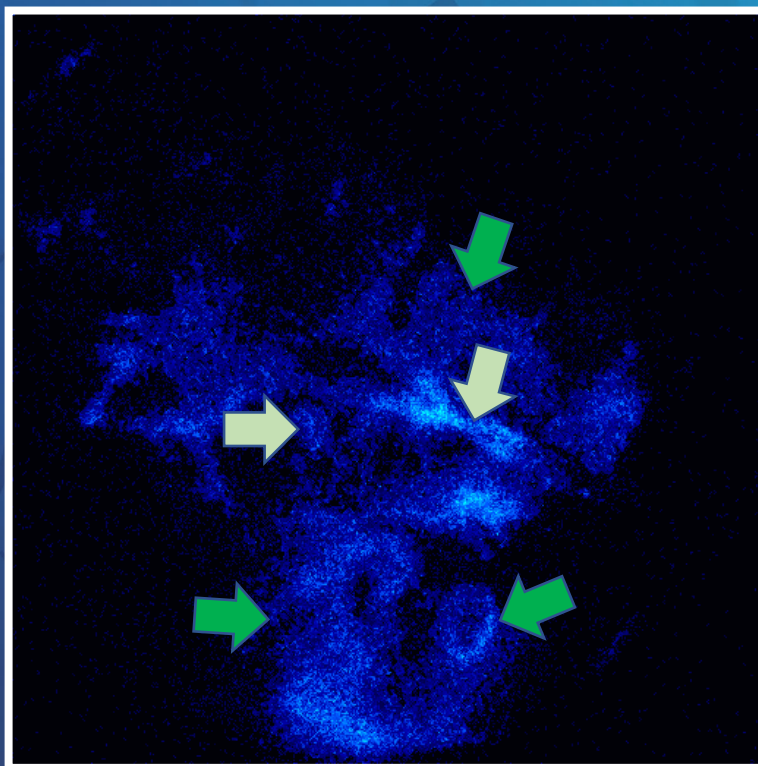
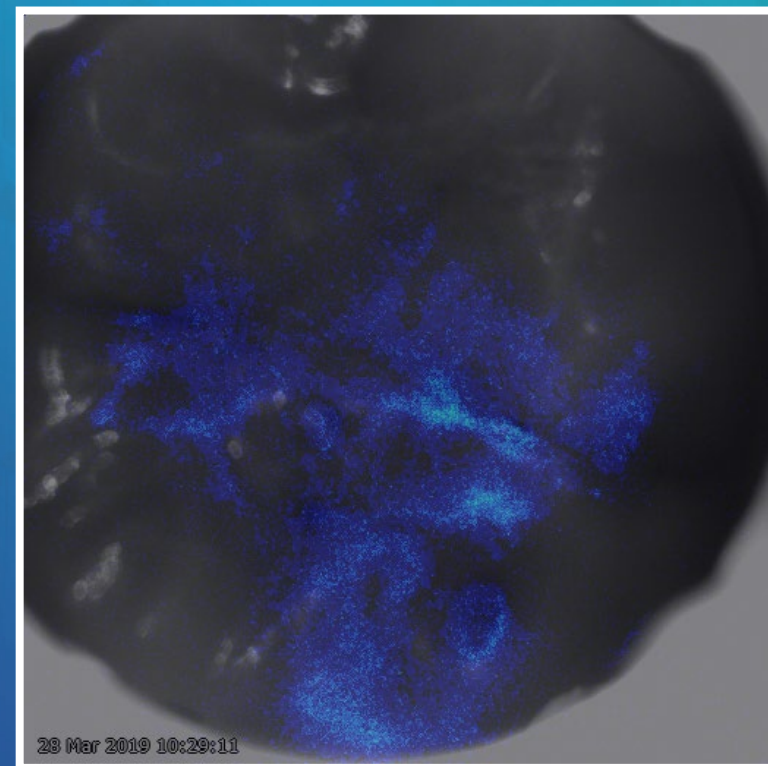
Fig. 8 – mild active demineralization, associated with caries

Tooth 19 (LL6) Occ - mild level of active demineralization across the occlusal surface. Areas of non-caries related demineralization indicated by green arrows, with areas of demineralization associated with previous caries lesion in pit and fissure indicated by light green arrows.

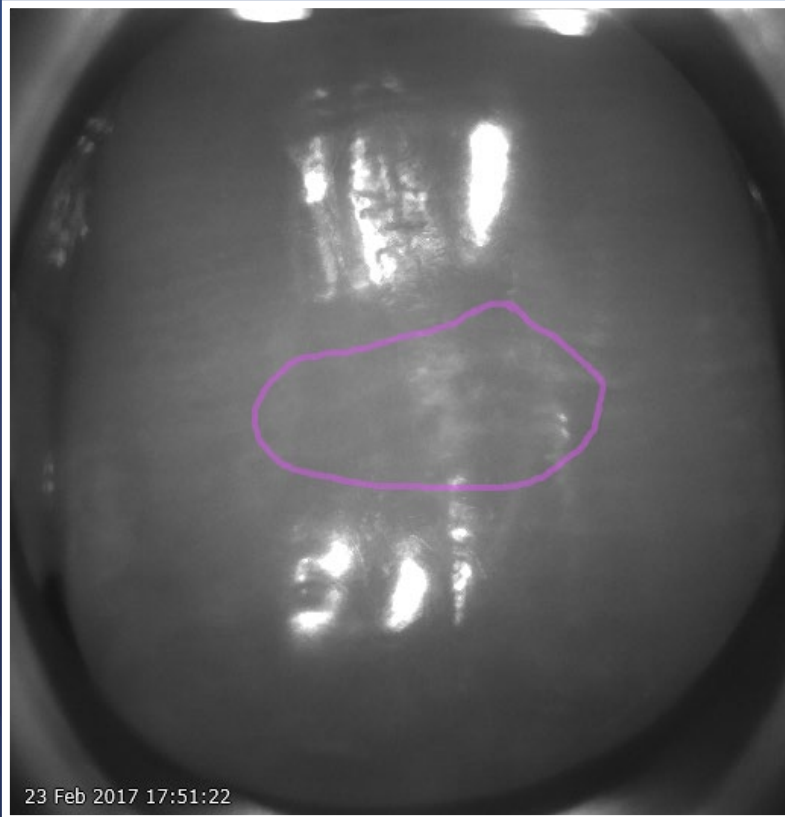
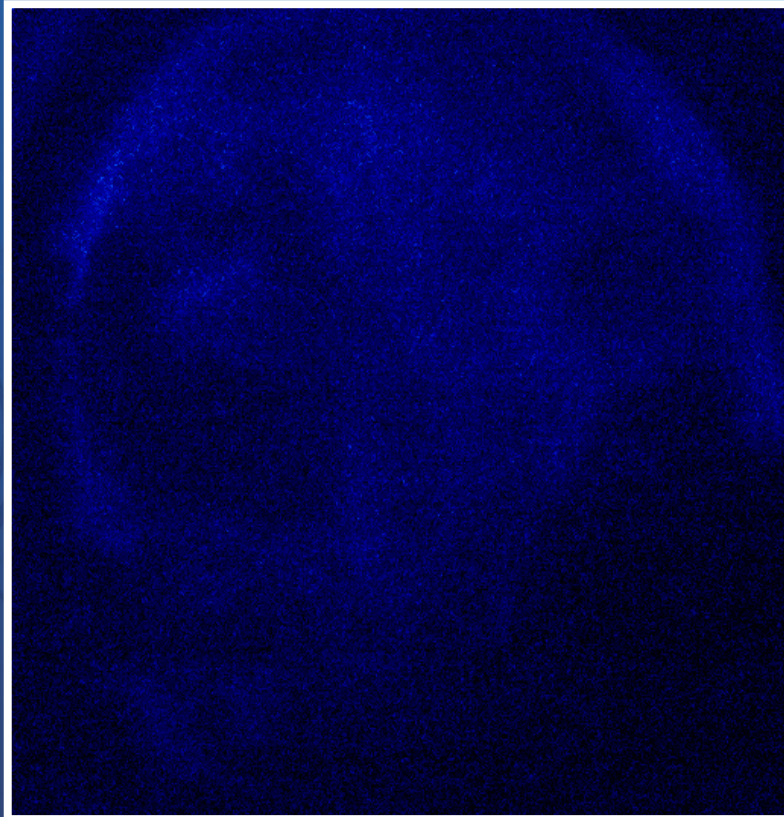
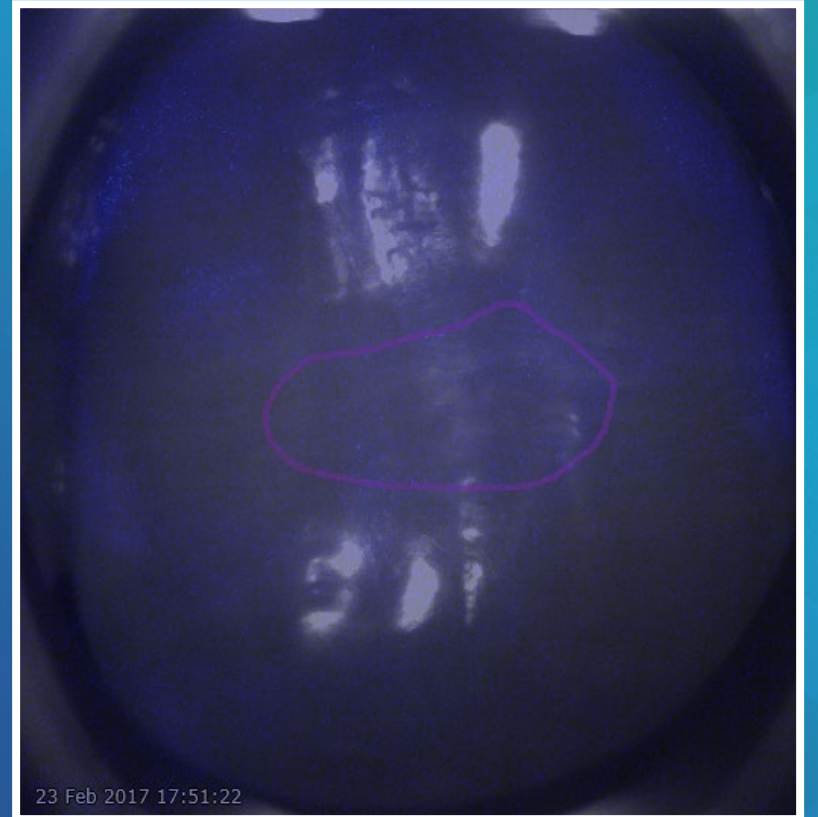
Fig. 9 – sound tooth, no active demineralization

Tooth 8 (UR1) Buc - no luminescence on buccal surface of tooth in area marked before imaging.

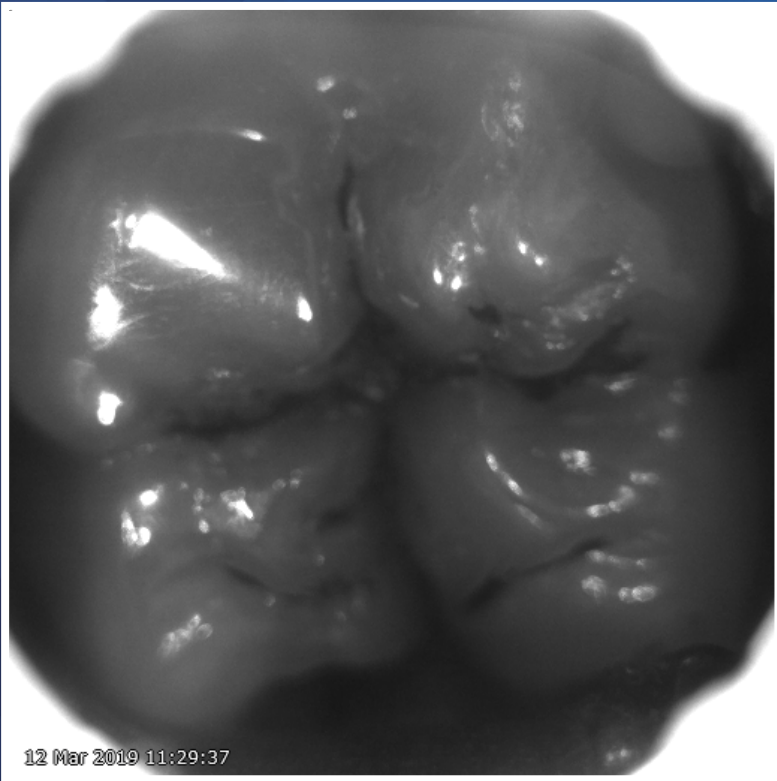
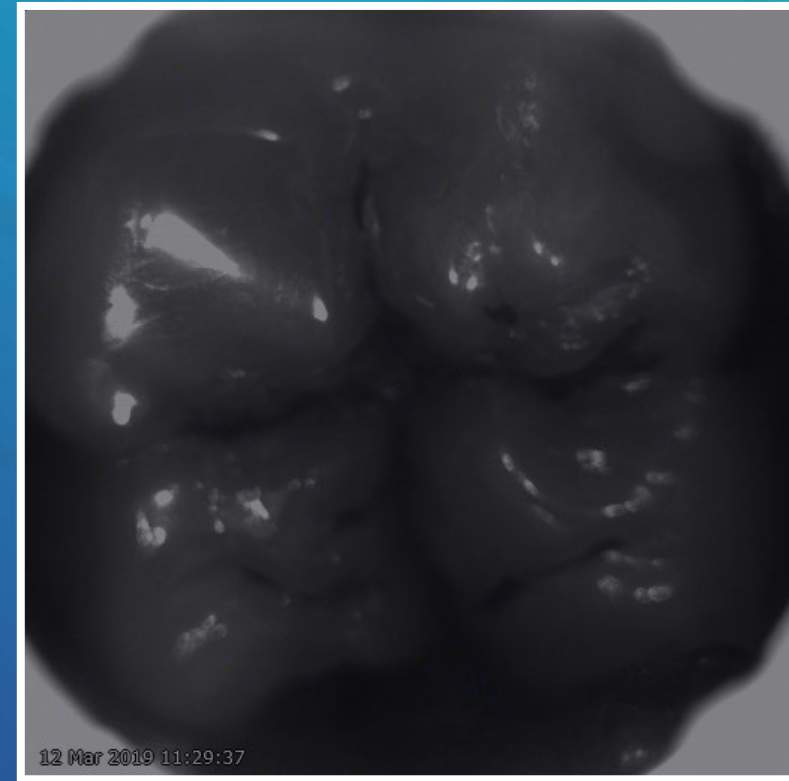
Fig. 10 – sound tooth, no active demineralization

Tooth 30 (LR6) Occ - Occlusal surface of sound tooth showing no luminescence.

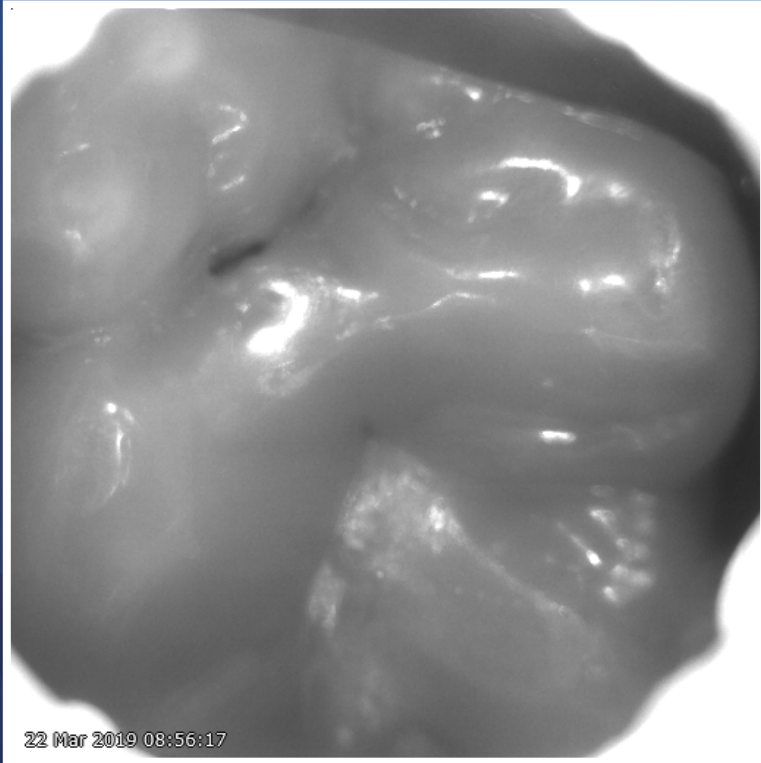
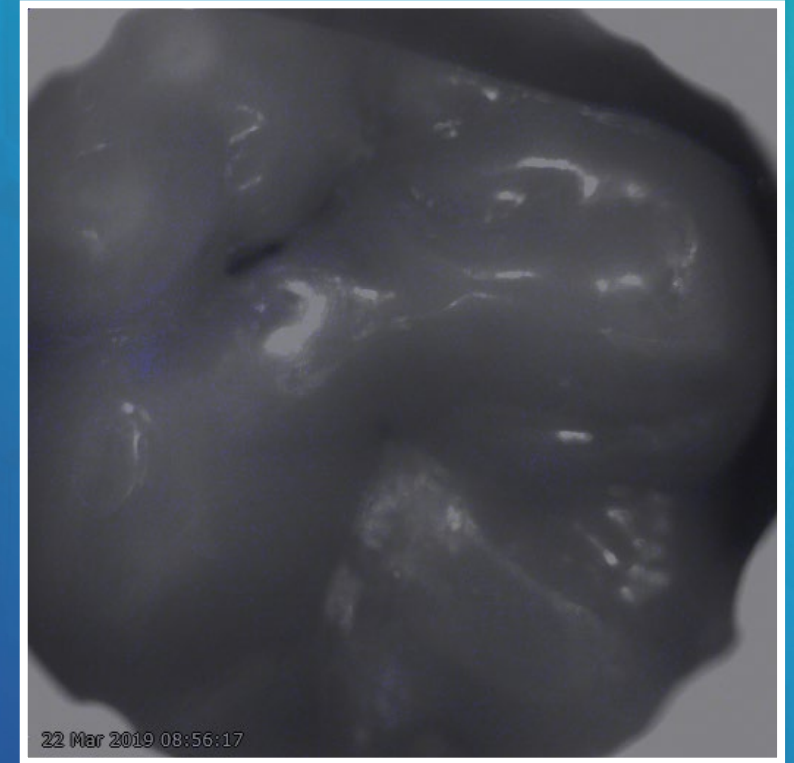
Fig. 11 – sound tooth, no active demineralization

Tooth 3 (UR6) Occ - occlusal surface of sound tooth showing no luminescence.

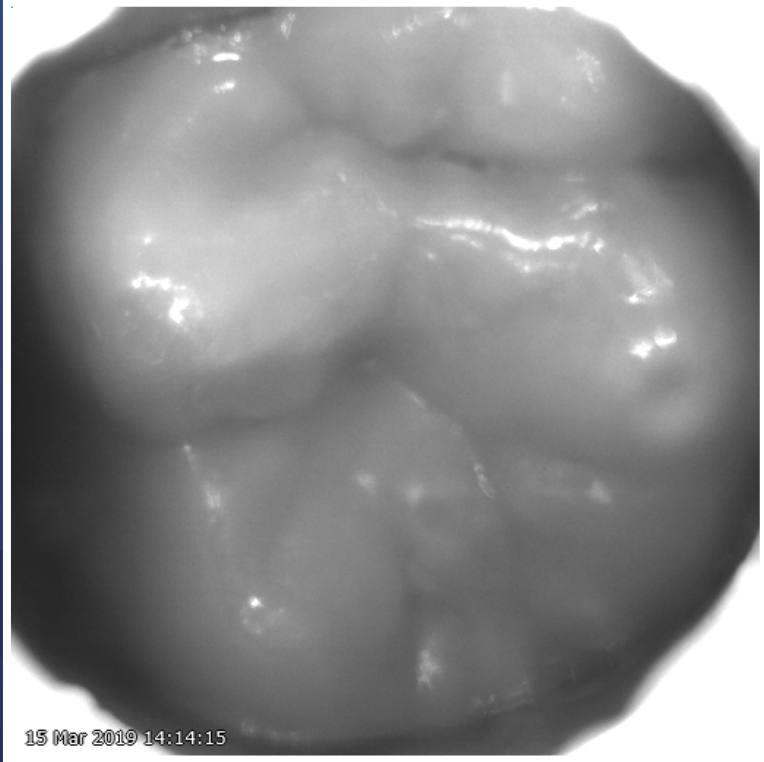
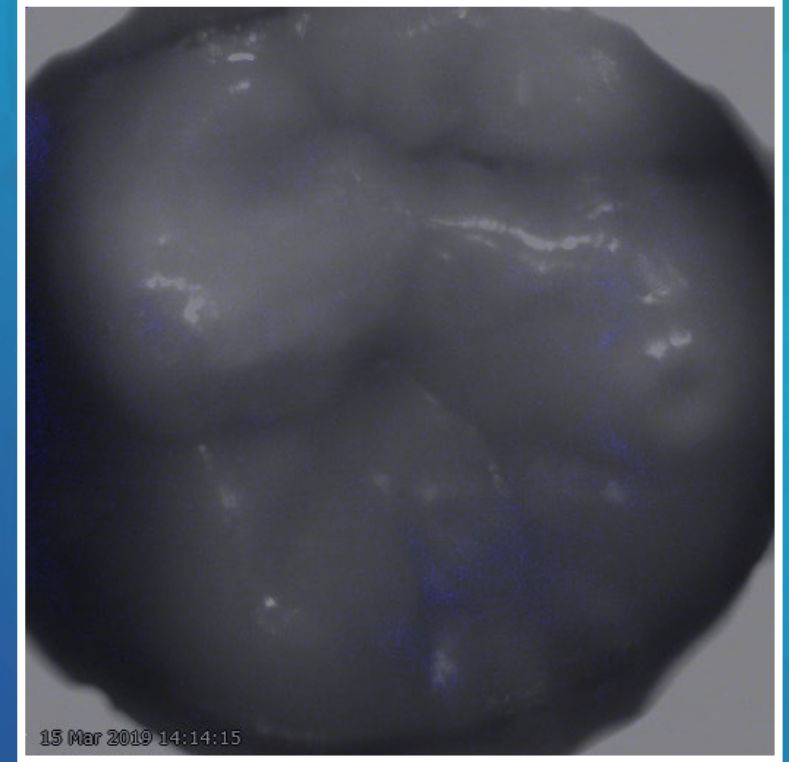
Fig. 12 – sound tooth, no active demineralization

Tooth 31 (LR7) Occ - occlusal surface of sound tooth showing no luminescence.

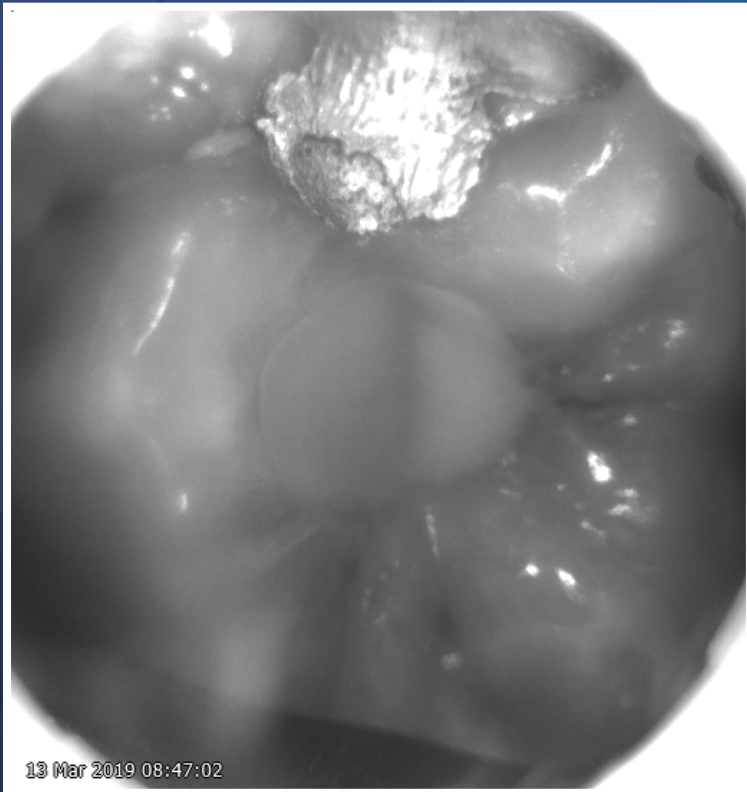
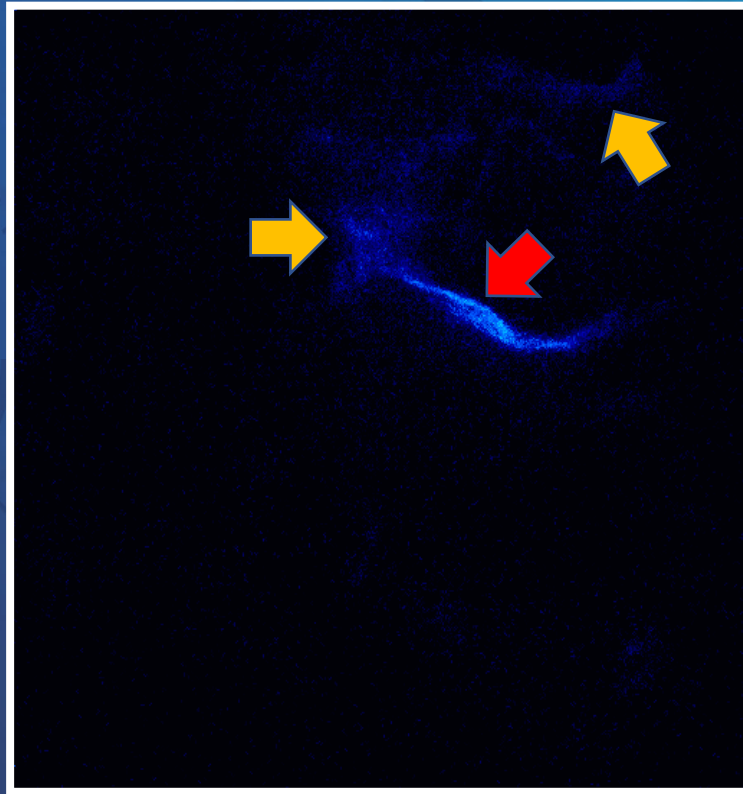
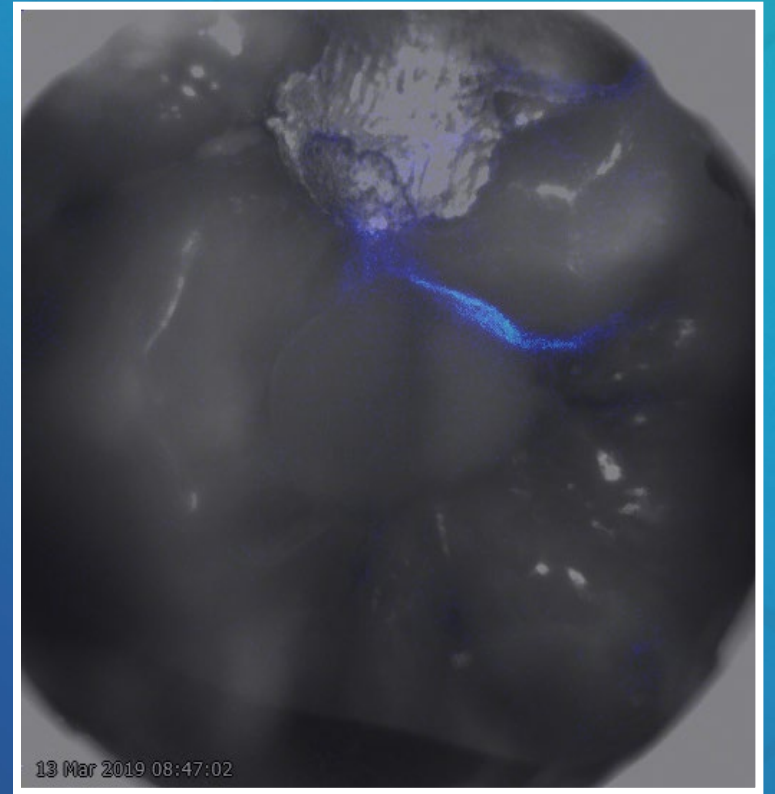
Fig. 13 – active demineralization at margins of restorations

Tooth 3 (UR6) Occ - active demineralization on margin of fissure sealant (red arrow) and possible activity on edges of amalgam (yellow arrows).
