CALCIVIS Imaging System

Image Interpretation Guidelines

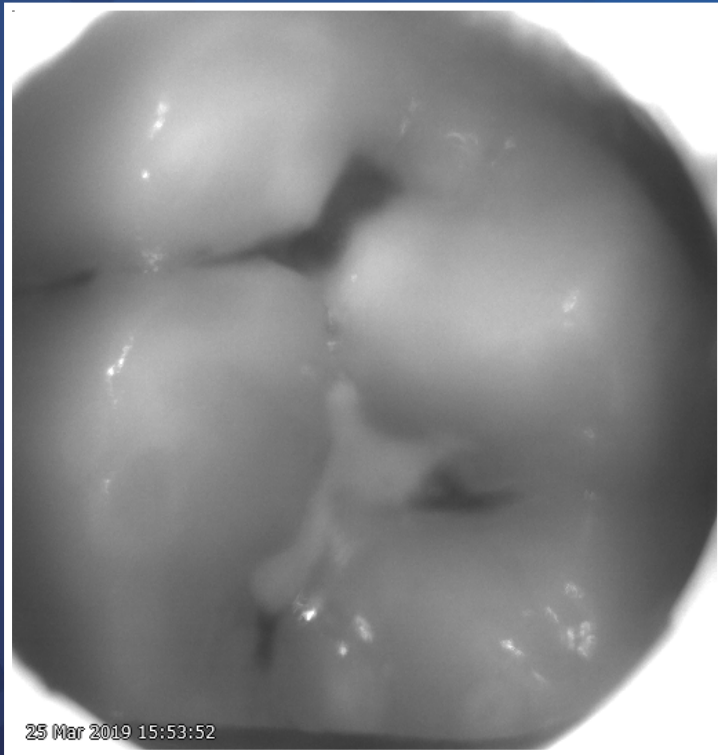
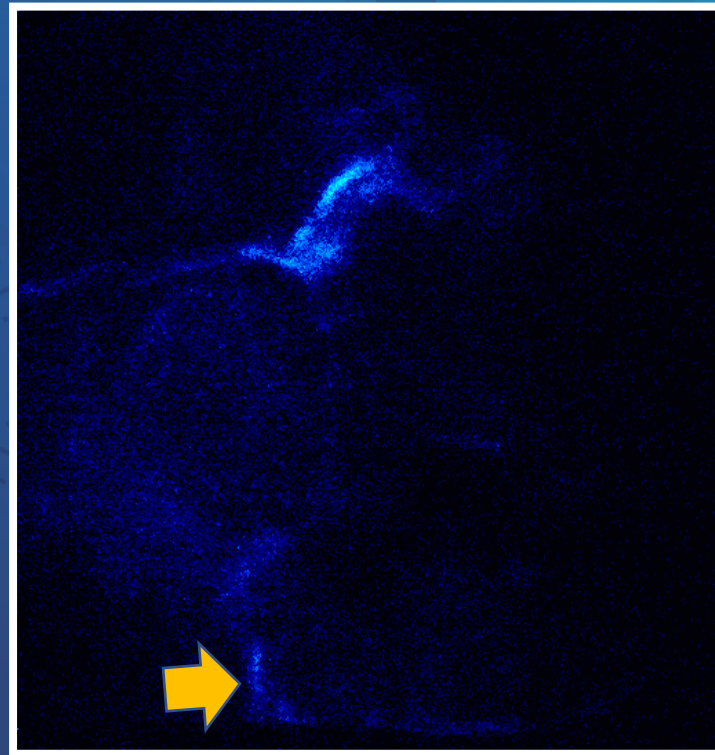
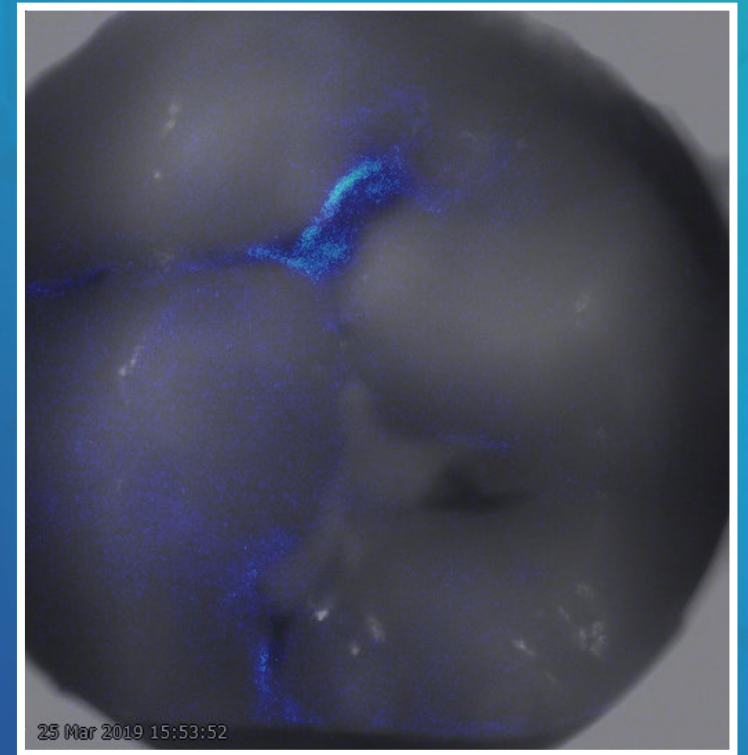
Fig. 14 – low active demineralization at margins of restorations

Tooth 3 (UR6) Occ - low level of active demineralization at lower edge of fissure sealant marked by yellow arrow.

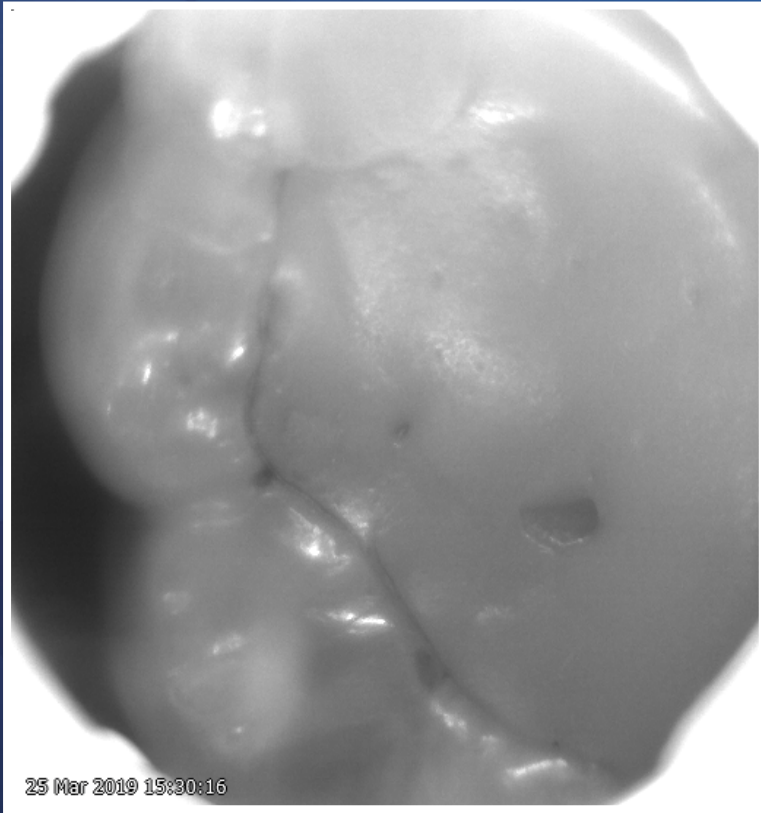
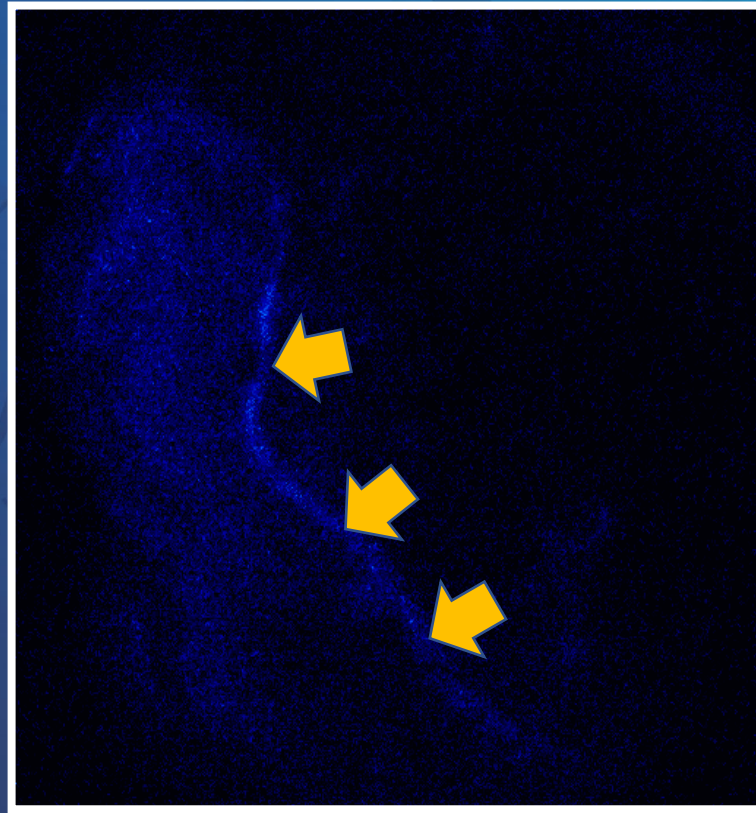
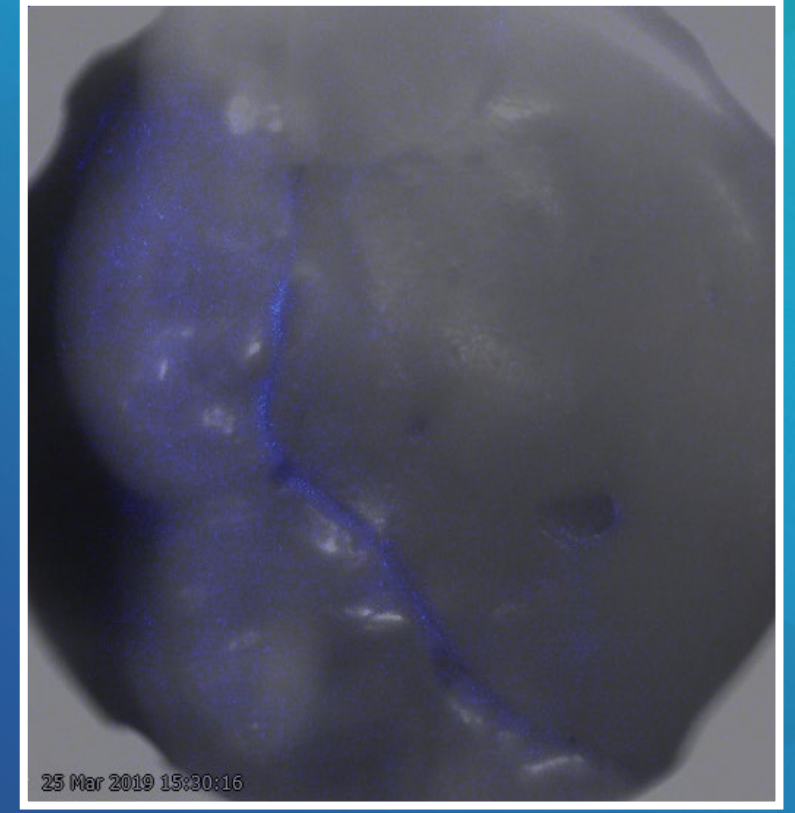
Fig. 15 – low active demineralization at margins of restorations

Tooth 3 (UR6) Occ - low level of active demineralization on edge of composite restoration marked by yellow arrows.

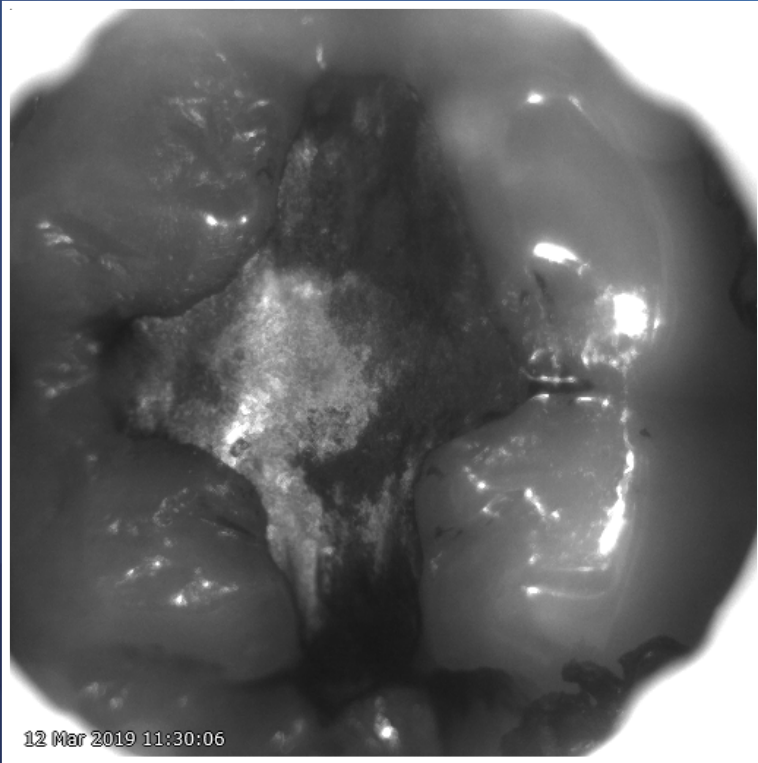
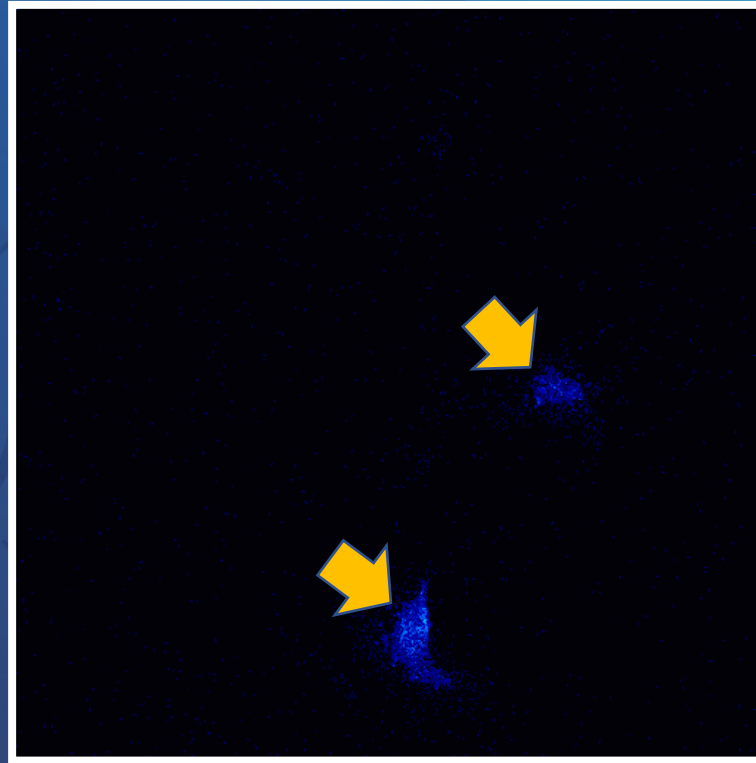
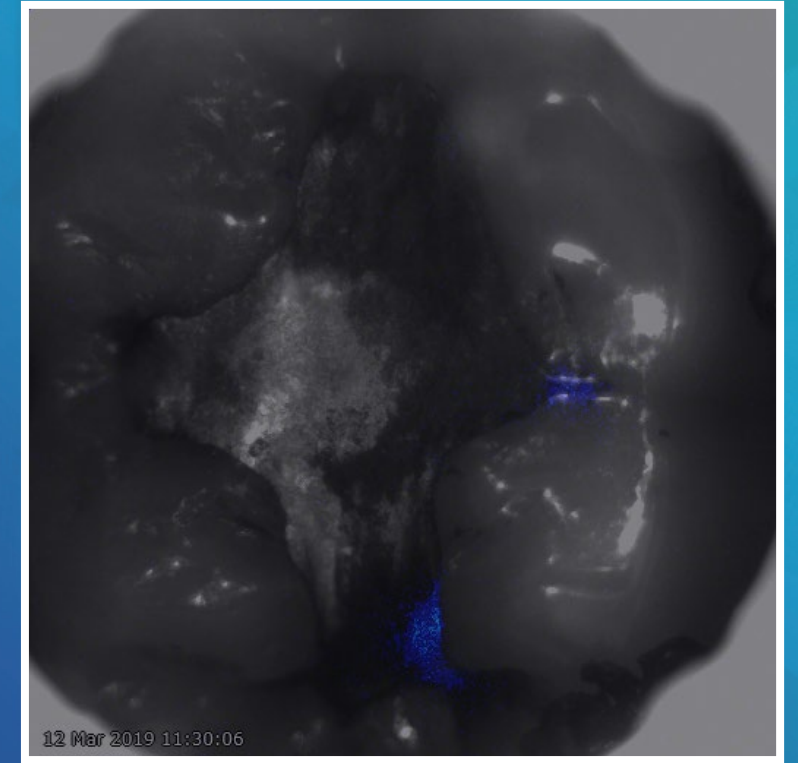
Fig. 16 – low active demineralization at margins of restorations

Tooth 19 (LL6) Occ - low level of active demineralization at outer edges of restoration marked by yellow arrows.

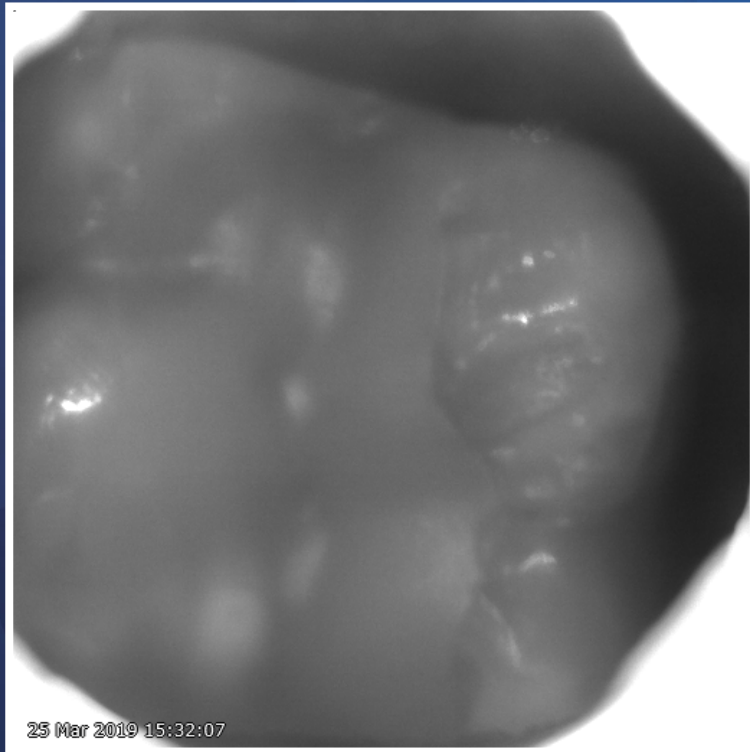
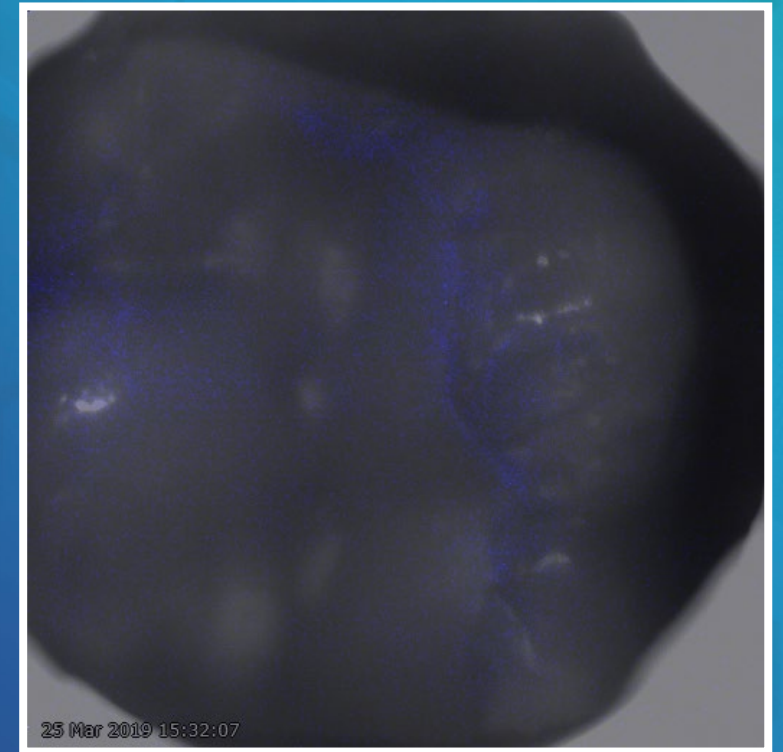
Fig. 17 – low active demineralization at margins of restorations

Tooth 3 (UR6) Occ - low level of active demineralization along edge of composite filling marked by yellow arrows.

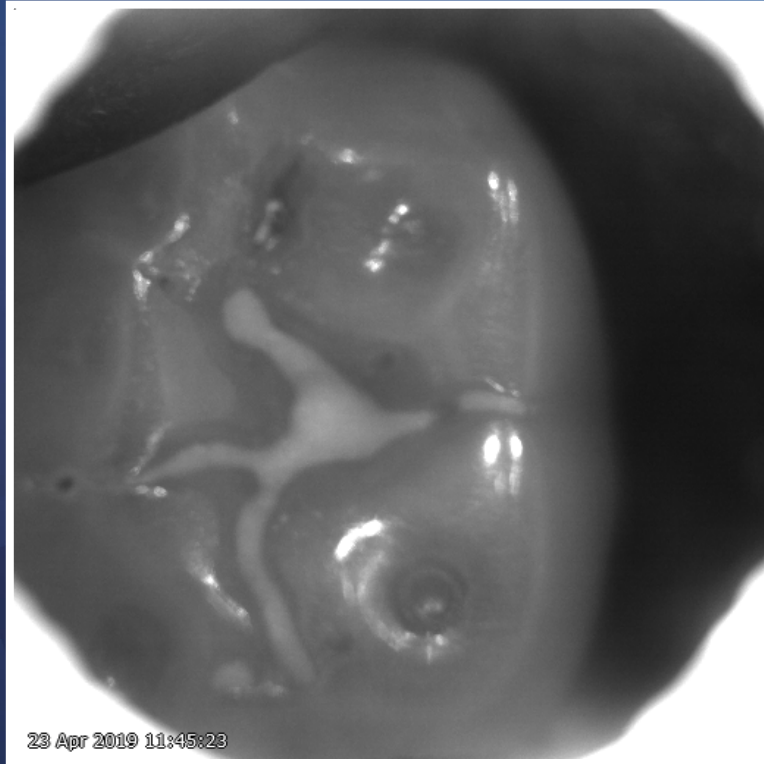
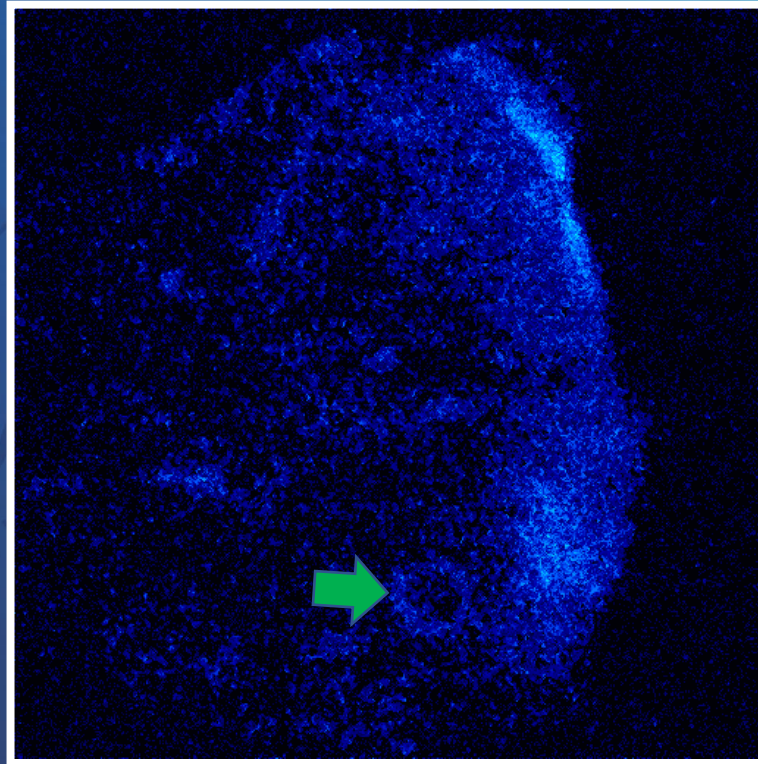
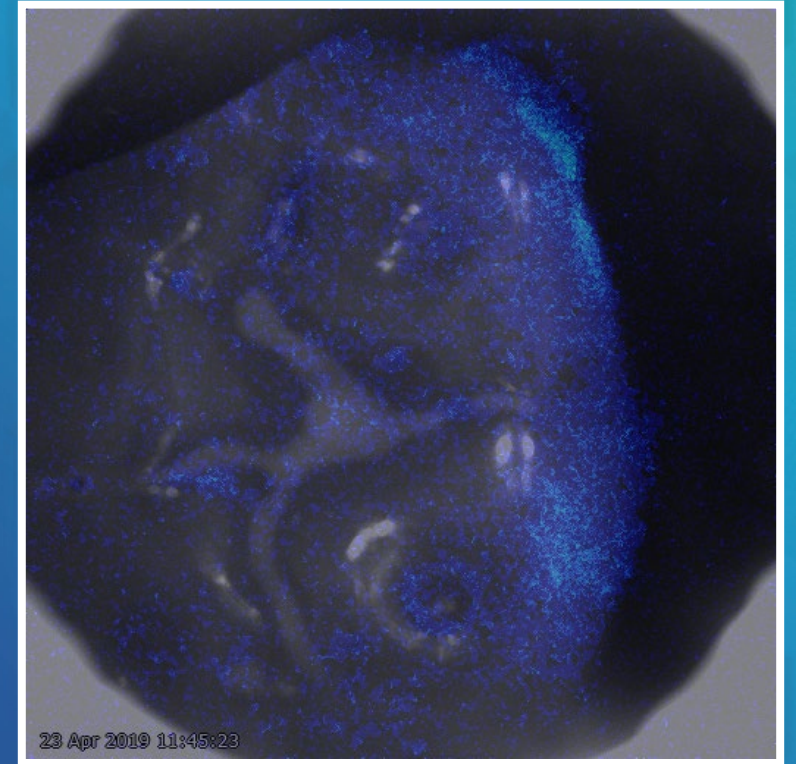
Fig. 18 - low level of non-carries associated active demineralization

Tooth 30 (LR6) Occ - Low level signal with circle of non-carries associated active demineralization on cusps (green arrow).

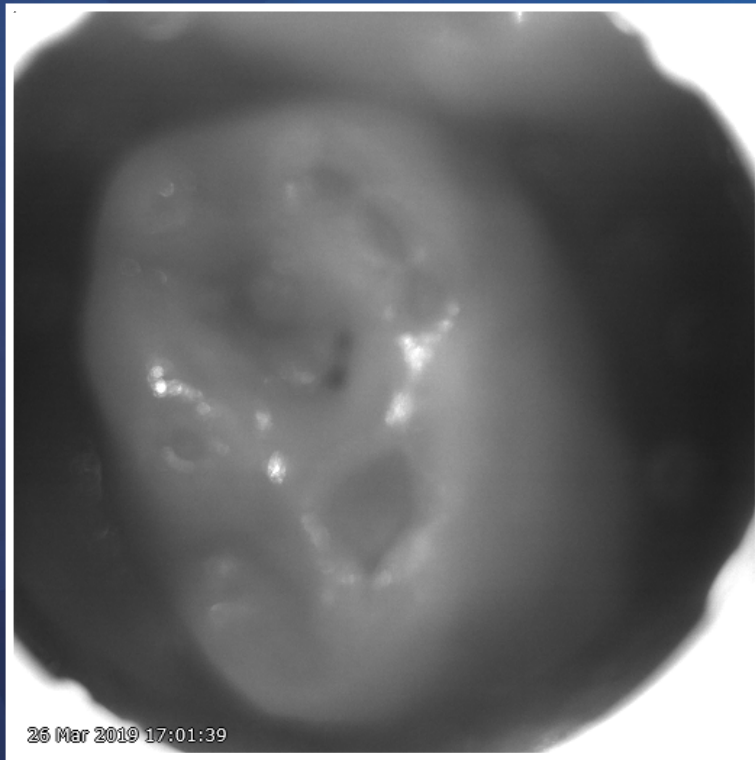
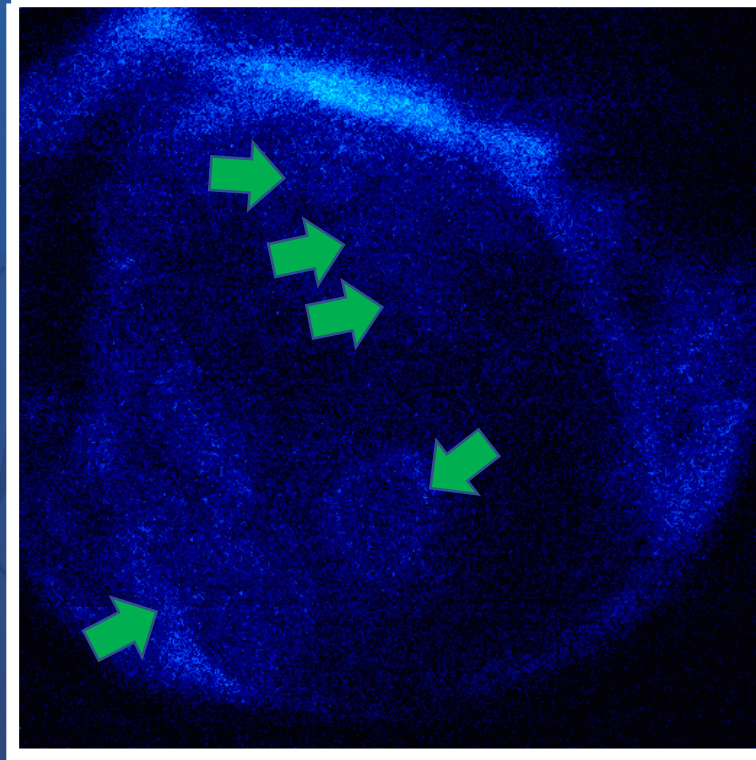
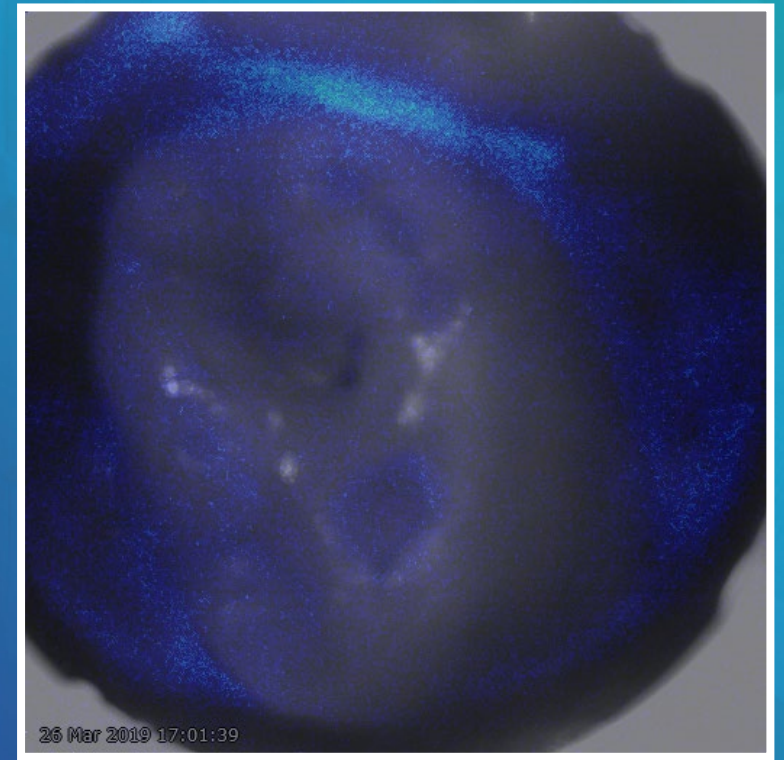
Figure 19 - low level of non-caries associated active demineralization.

Tooth 21 (LLD) Occ - low level (circle) of non-caries associated active demineralization on cusps.

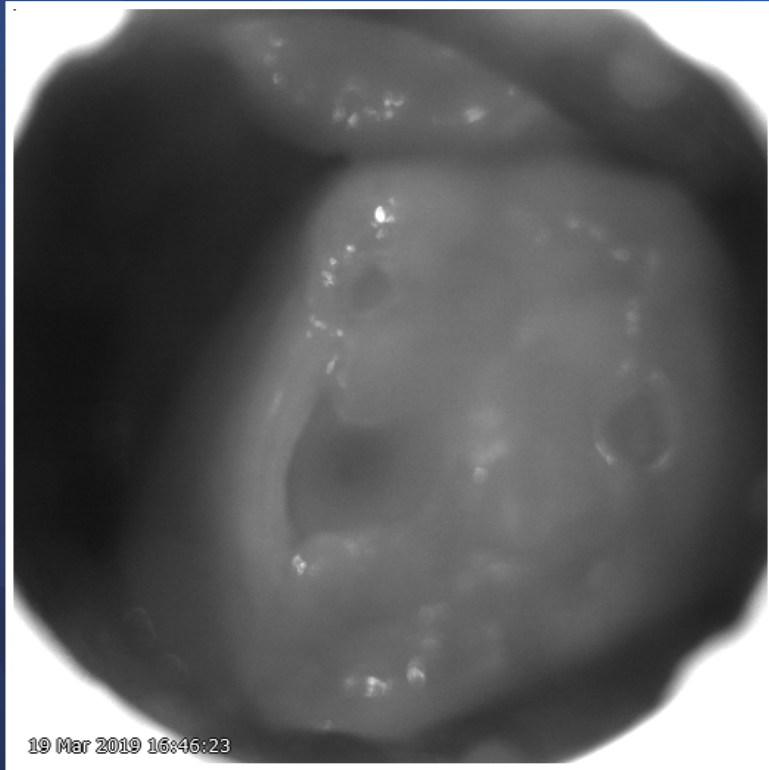
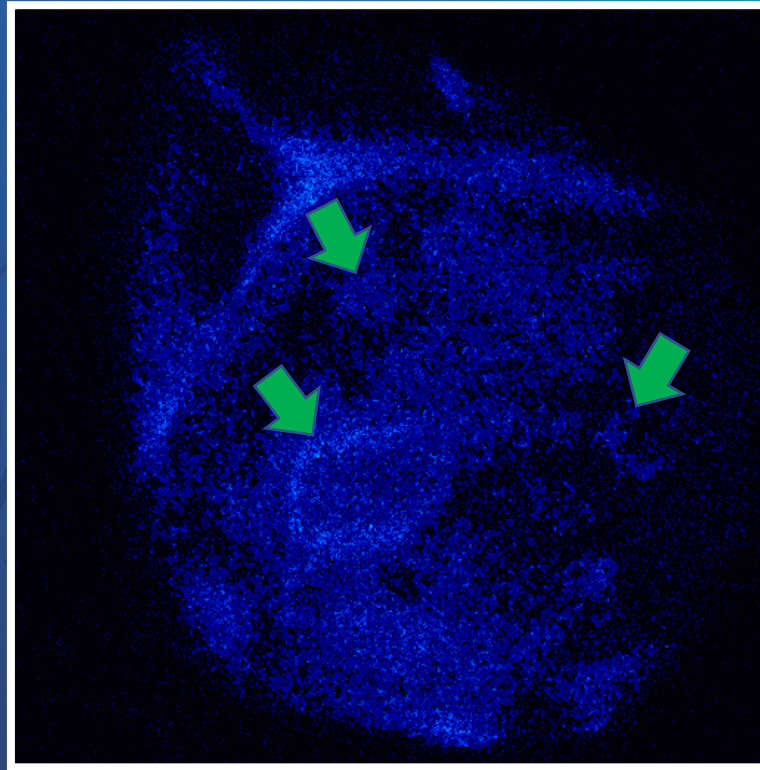
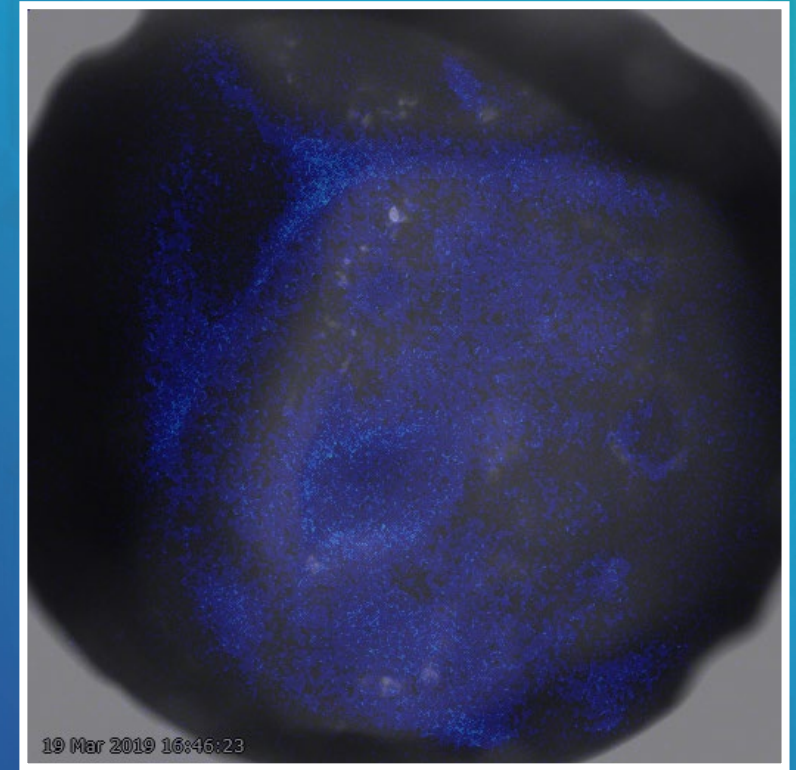
Figure 20 - low level of non-carries associated active demineralization

Tooth 12 (ULD) Occ - low level of non-carries associated active demineralization with delineated areas.

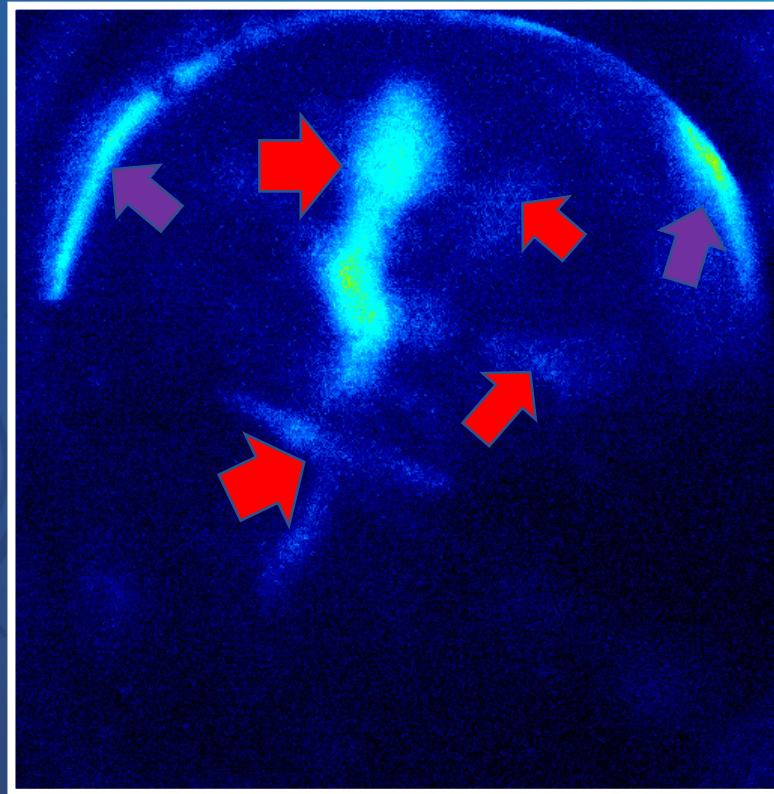
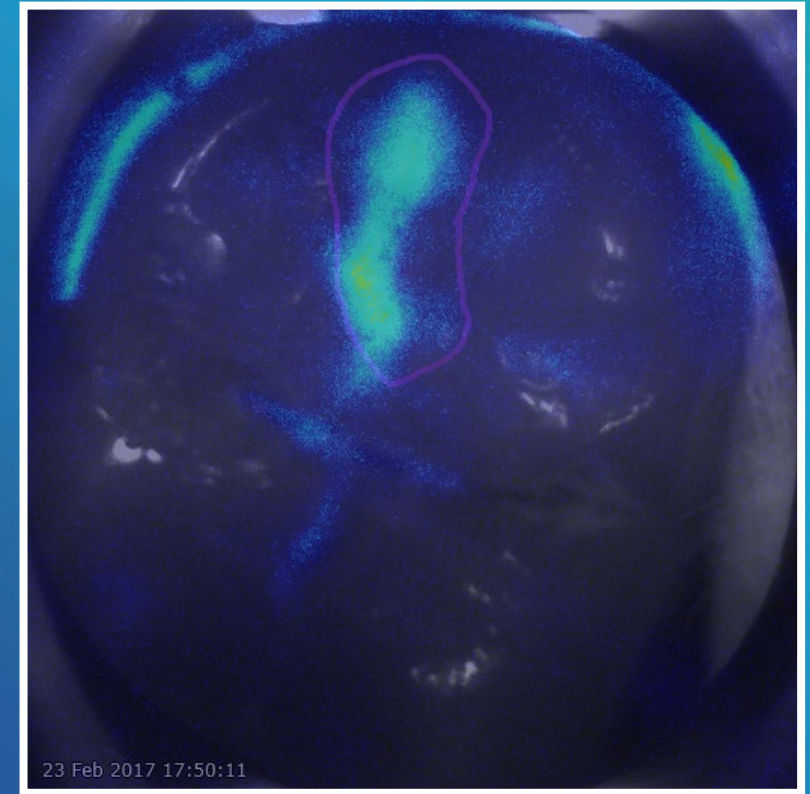
Fig. 21 – signal around edge of tooth caused by saliva

Tooth 31 (LR7) Occ - obvious moderate level of active demineralization (red arrows) in area marked by clinician before imaging, and also around the outside area marked. Signal around edges of tooth caused by saliva (purple arrows).

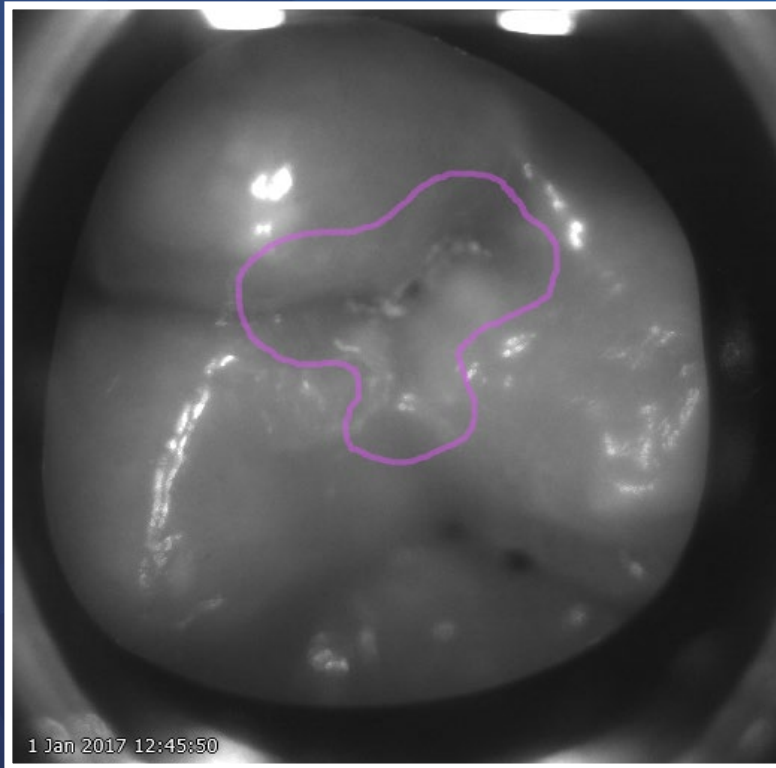
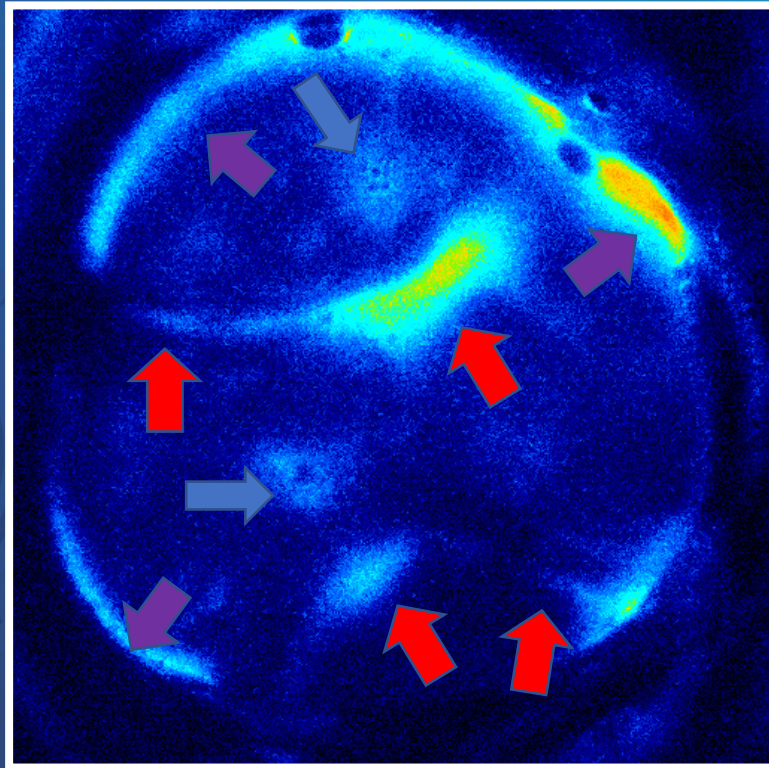
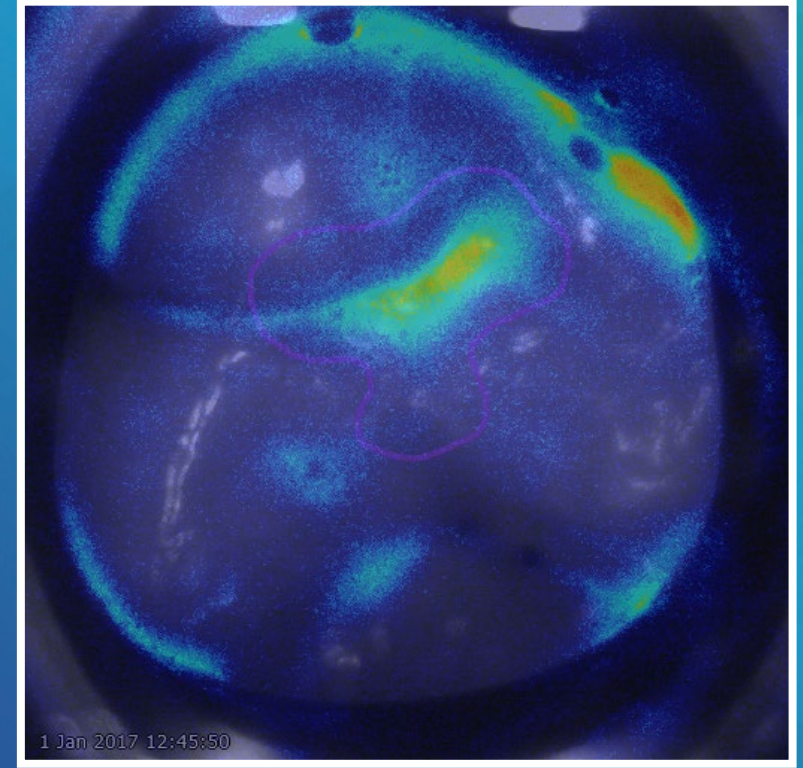
Figure 22 – signal around upper edge of tooth caused by saliva

Tooth 3 (UR6) Occ - high level of active demineralization (red arrows) in area marked by clinician, and also outside area marked, indicating demineralization more extensive than initially thought.

Areas of potential developmental hypo-mineralization are indicated by blue arrows.

Signal around edge of tooth caused by saliva (purple arrows).

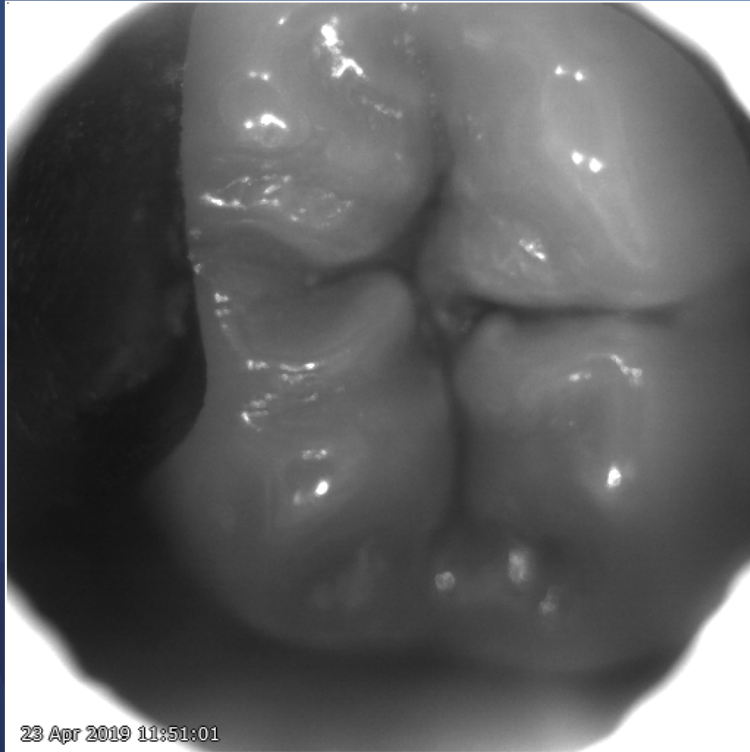
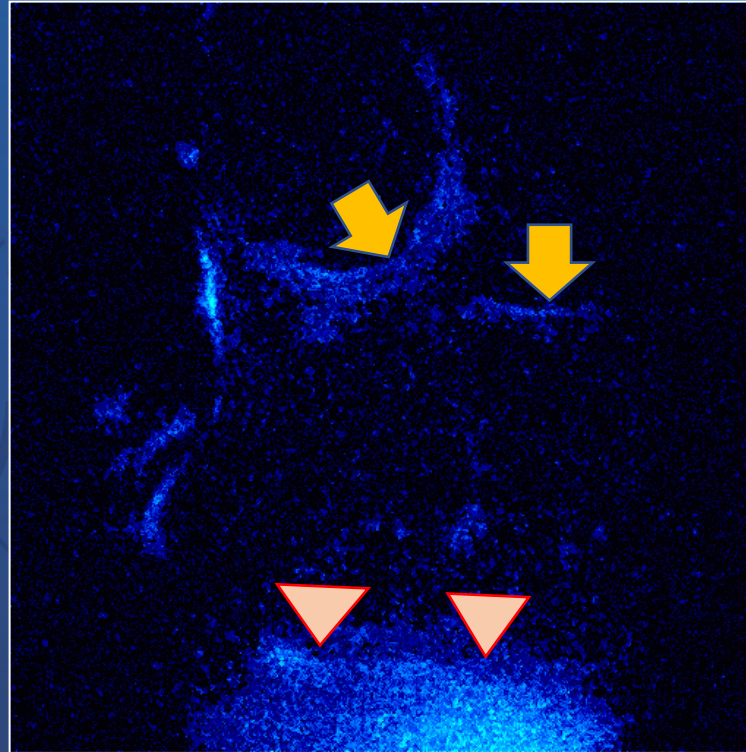
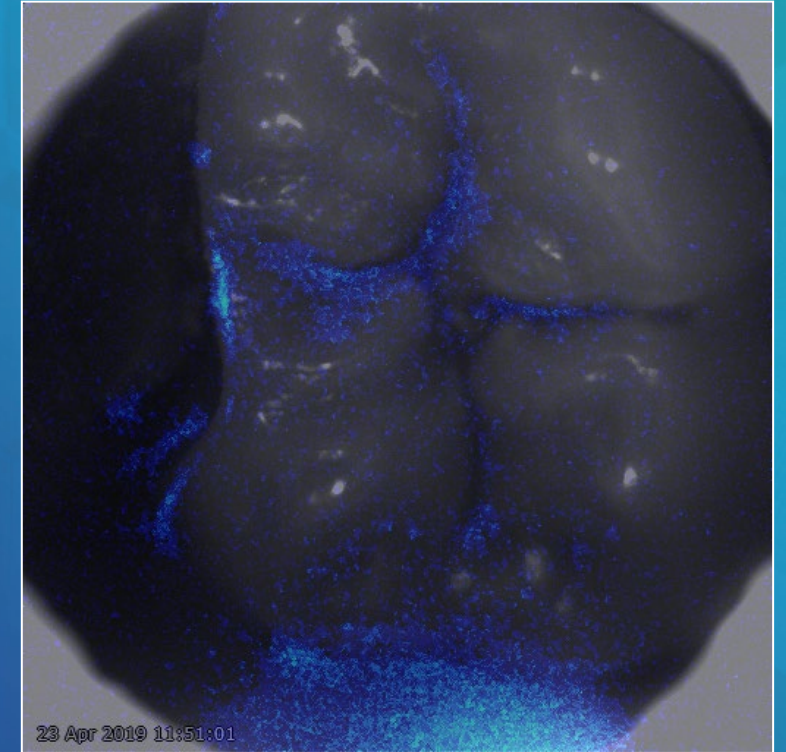
Figure 23 - signal at lower edge from light ingress

Tooth 18 (LL7) Occ - low level of active demineralization associated with fissure.
Bright area at lower edge from light ingress.

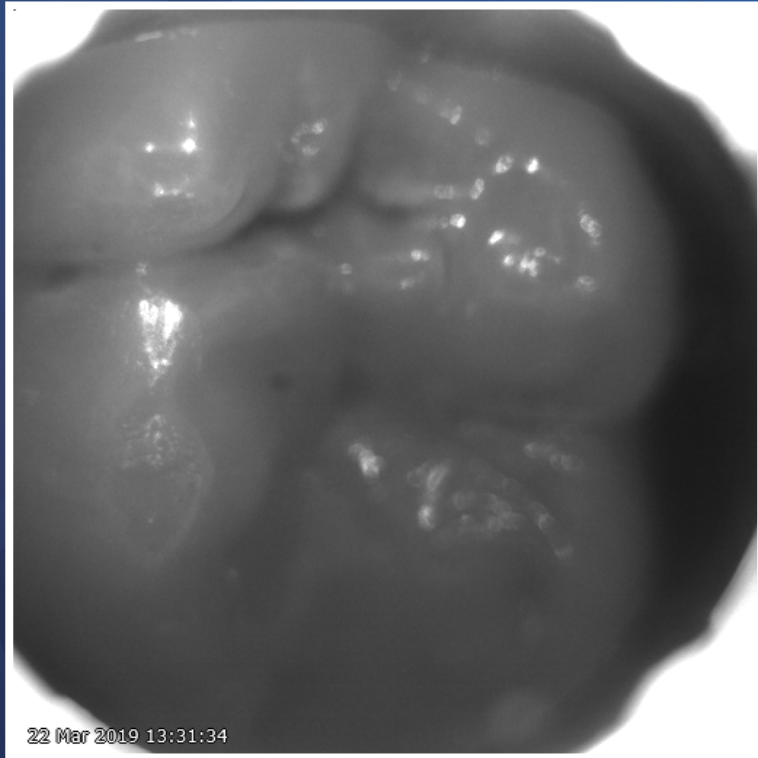
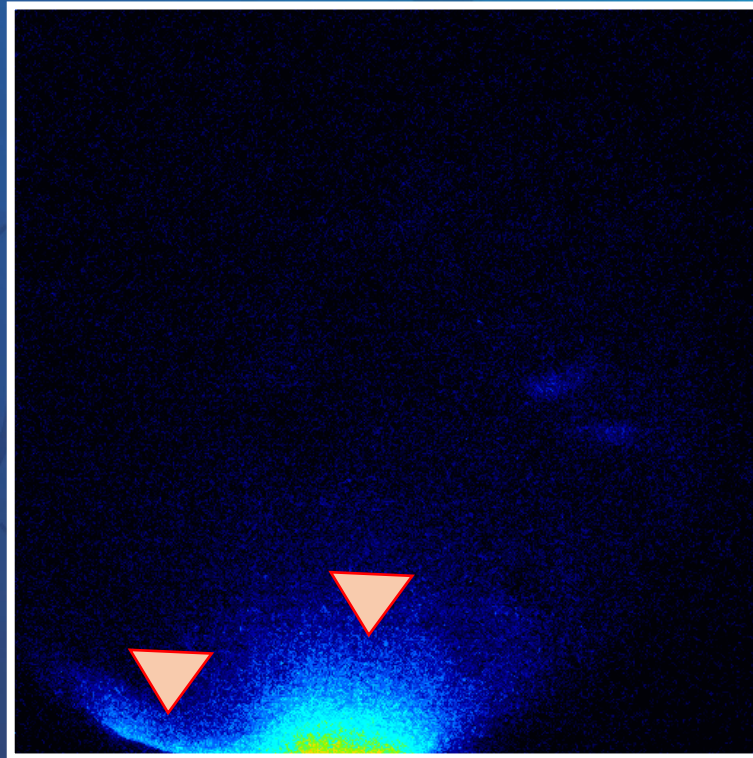
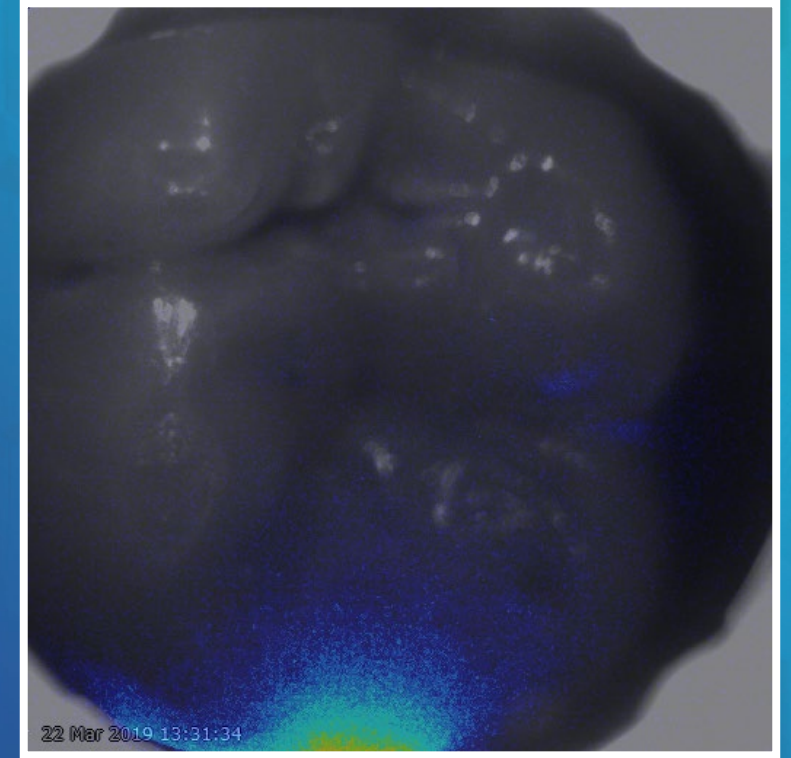
Figure 24 - signal at lower edge from light ingress

Tooth 3 (UR6) Occ - Light ingress on lower edge.

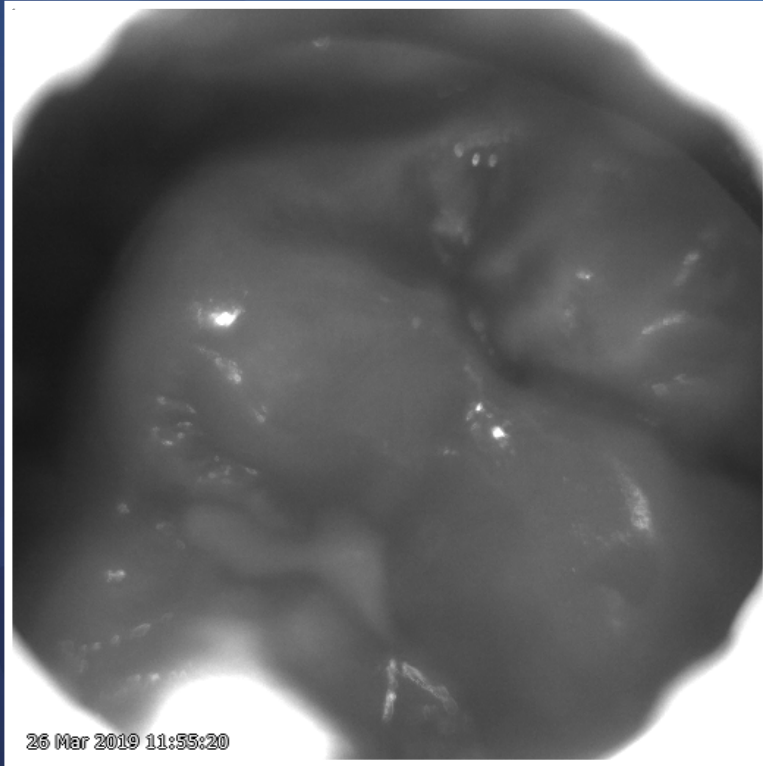
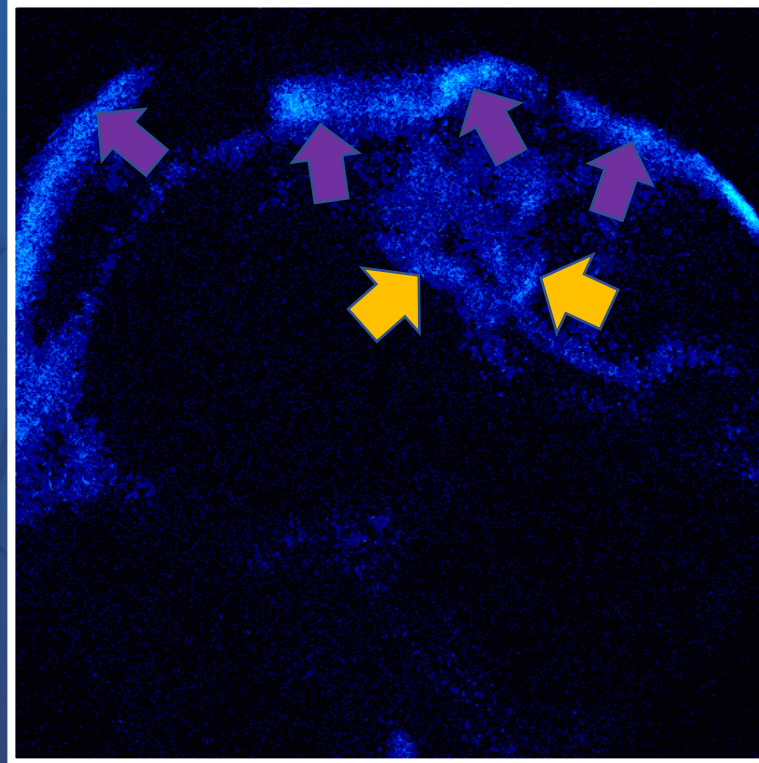
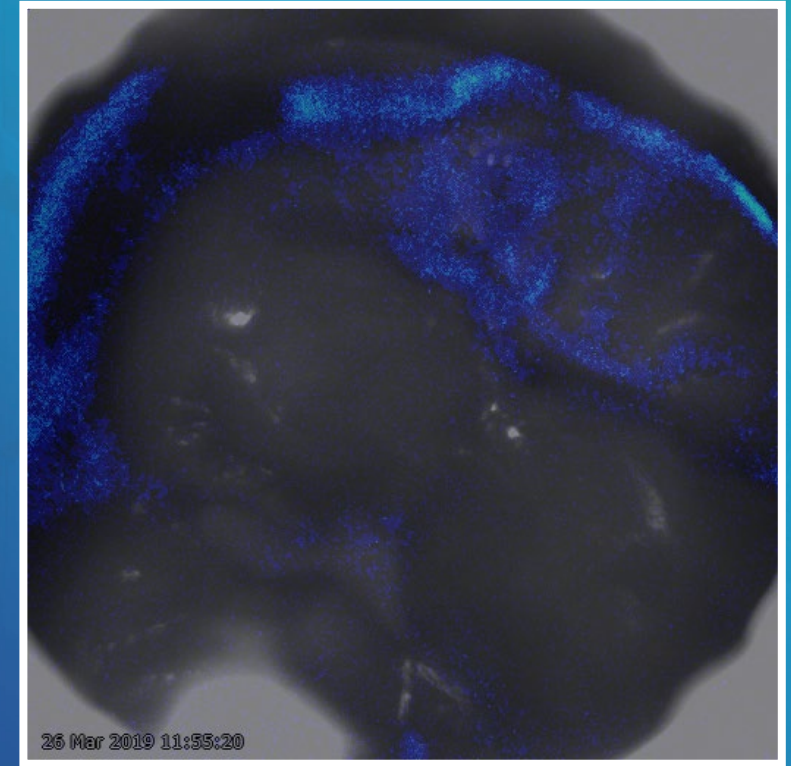
Figure 25 - signal caused by saliva from adjacent tooth

Tooth 14 (UL6) Occ - low level of active demineralization on tooth surface (yellow arrows), but area around edge of tooth due to saliva from adjacent tooth purple arrows).

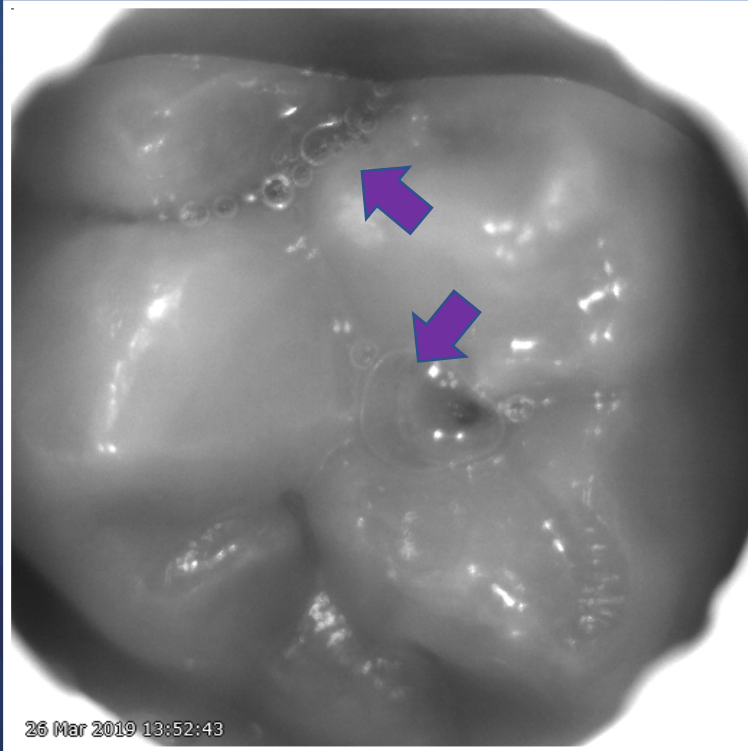
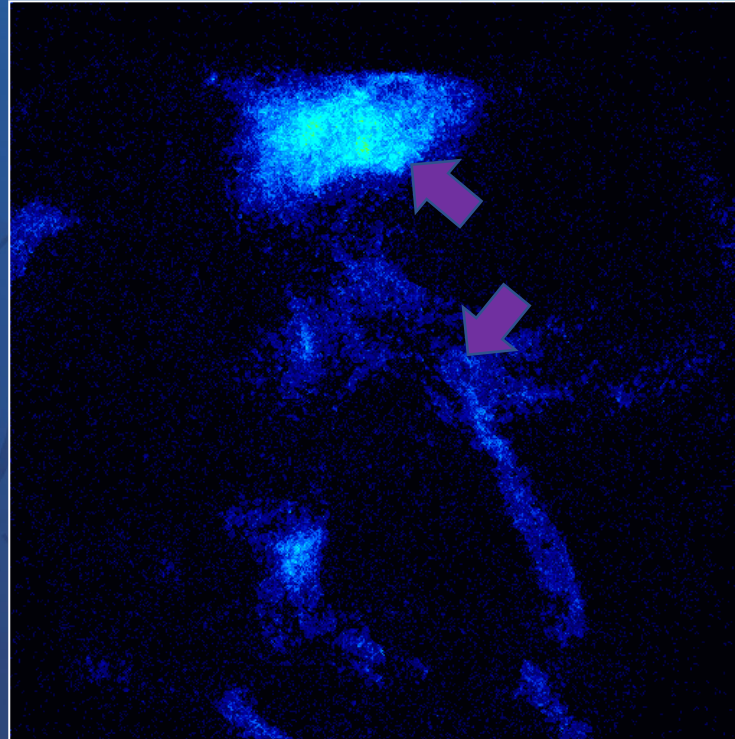
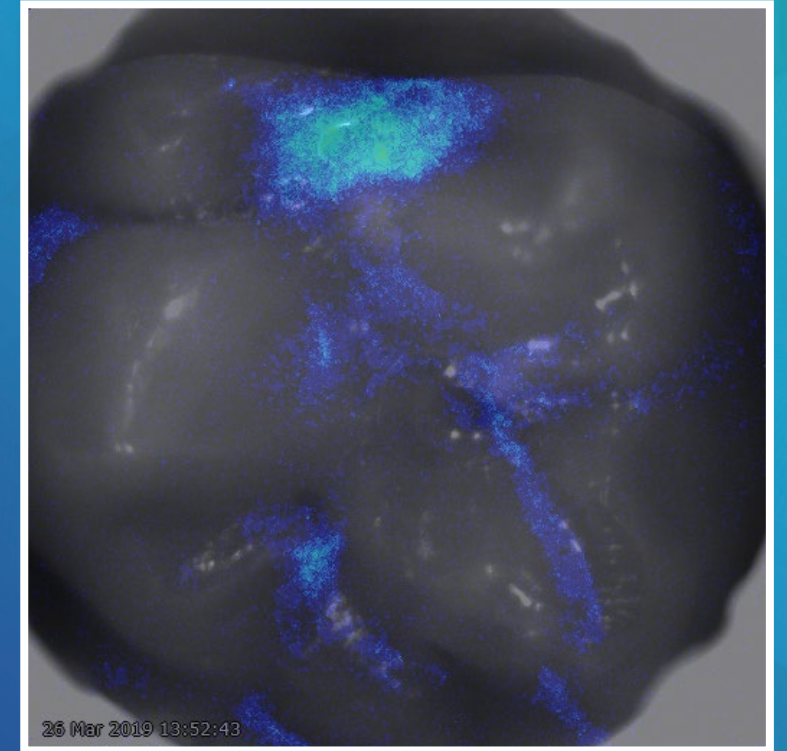
Fig. 26 – main signal due to bubbles of saliva

Tooth 3 (UR6) Occ - although some low levels of active demineralization noted, main areas of signal (purple arrows) due to bubbles of saliva – tooth not dried sufficiently.
Should be reimaged after rinse and dry.
