CALCIVIS Imaging System

Image Interpretation Guidelines

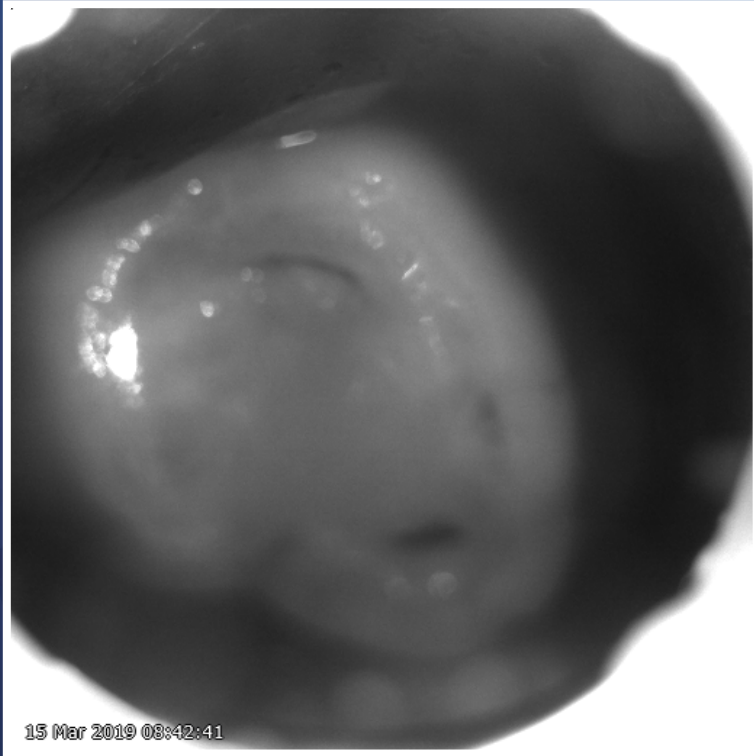
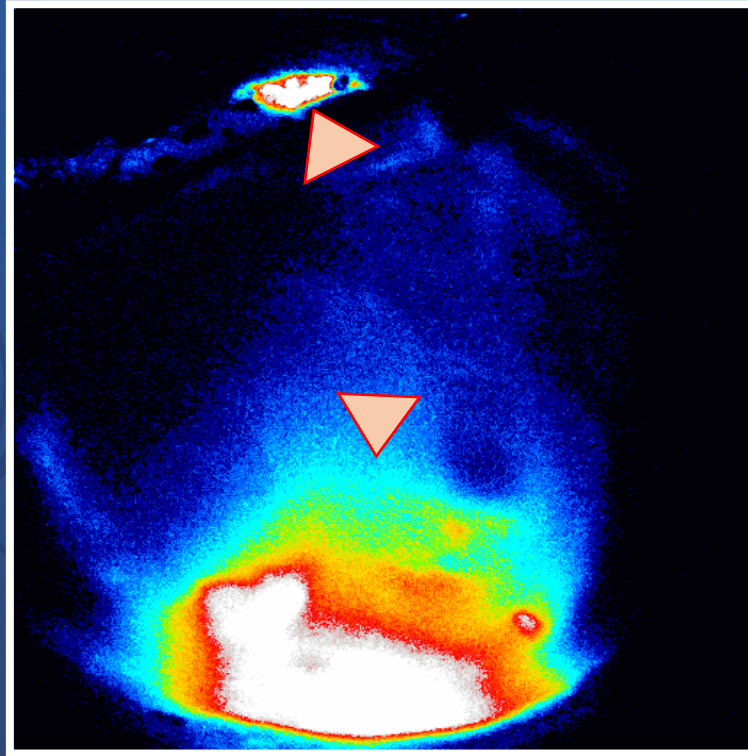
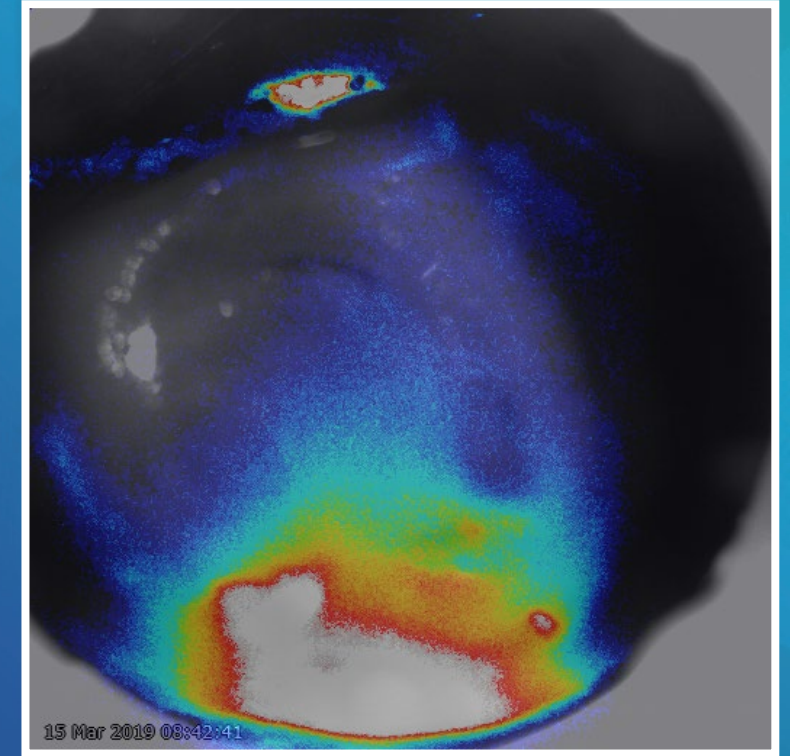
Figure 27 – image uninterpretable due to light ingress and poor focus

Tooth 5 (URD) Occ - image uninterpretable due to light ingress.
Also, the picture is out of focus as the device should be pressed firmly against the tooth surface.

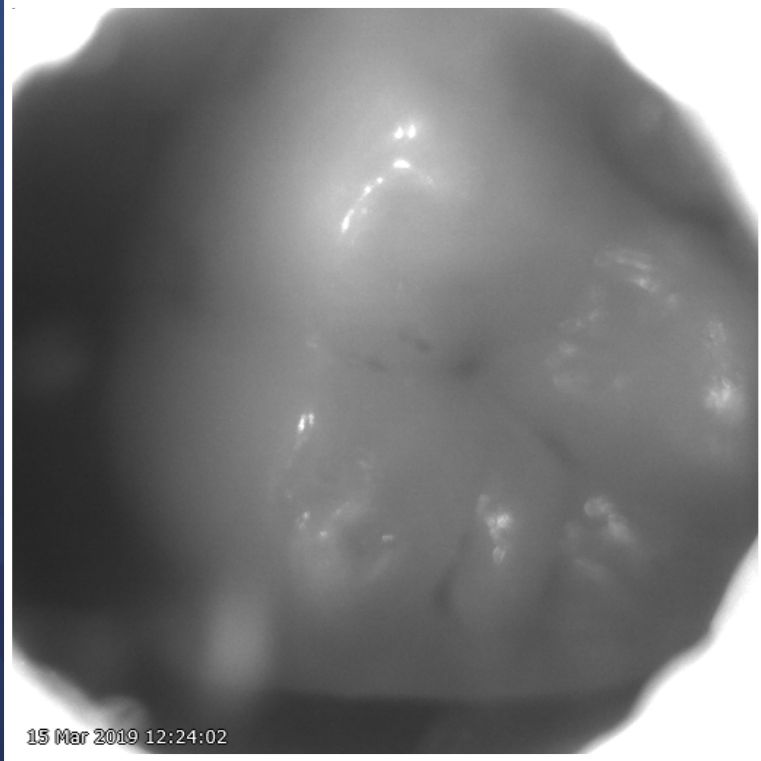
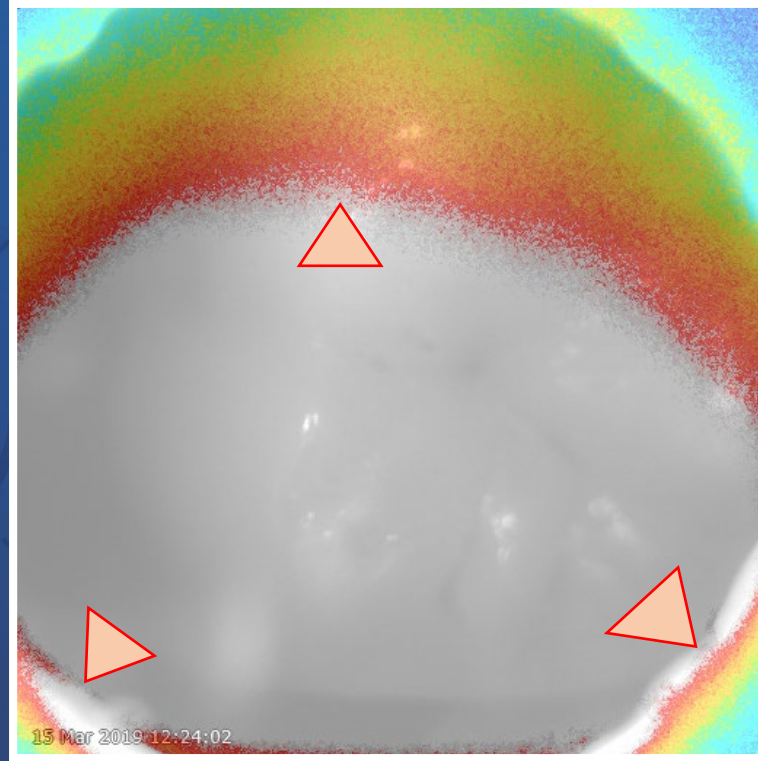
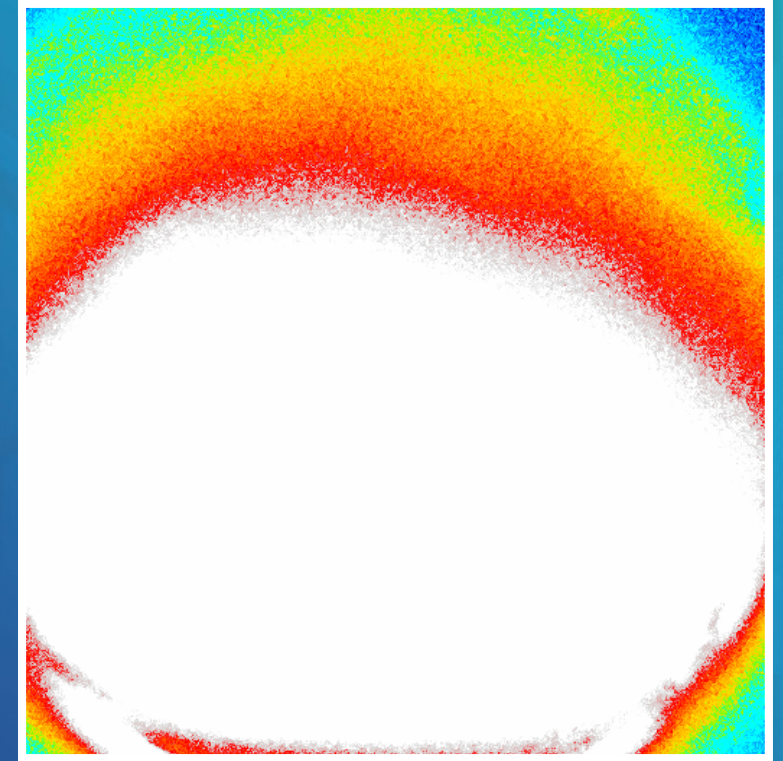
Figure 28 – overhead light left on

Tooth 14 (UL6) Occ - image uninterpretable –overhead light left on.

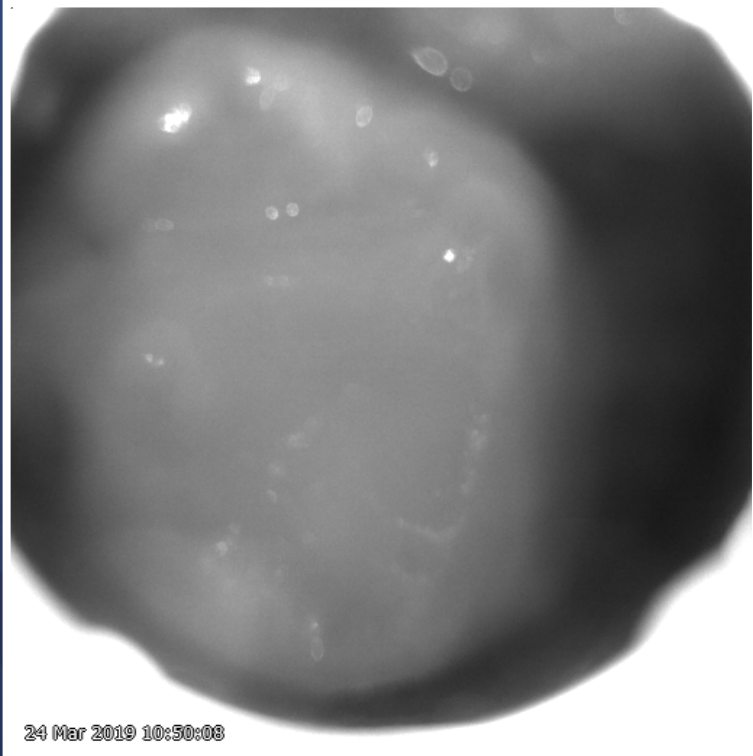
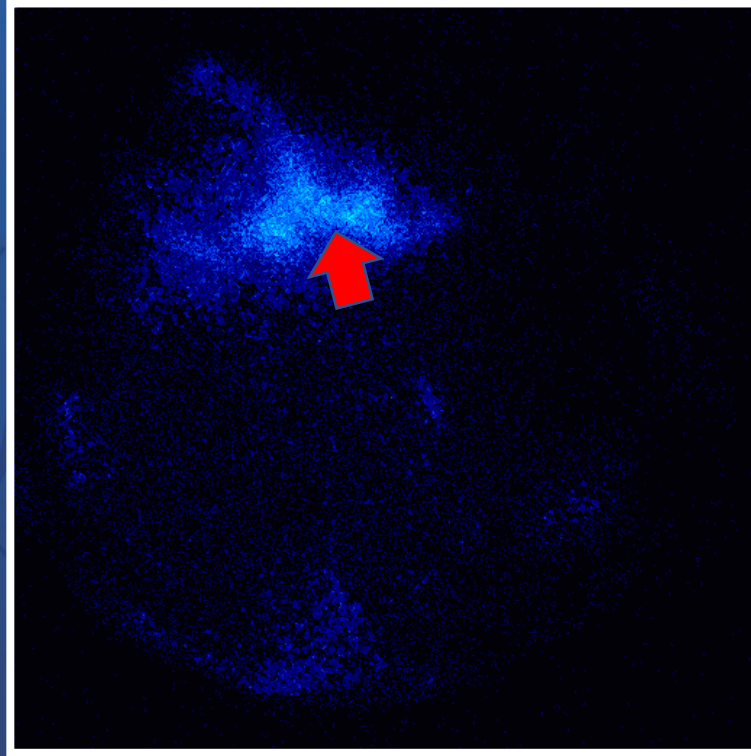
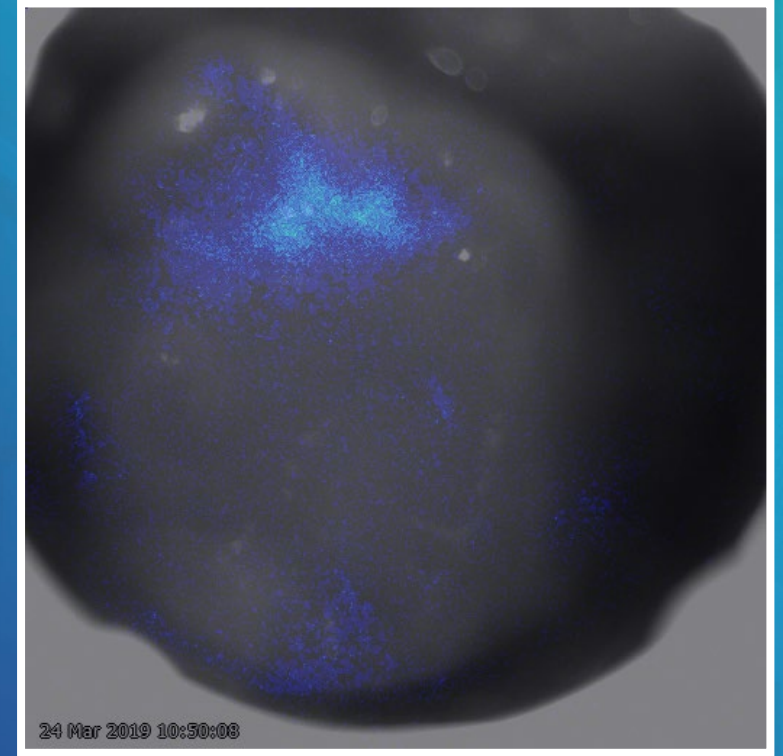
Figure 29- interpretation difficult as image out of focus

Tooth 5 (URD) Occ - active demineralization noted, but unclear if associated with caries lesion due to image being out of focus
